INVESTIGATOR HOME INSPECTIONS

PROPERTY INSPECTION REPORT

404 Somewhere Lane
Weatherford TX 76087

MAY 30, 2019

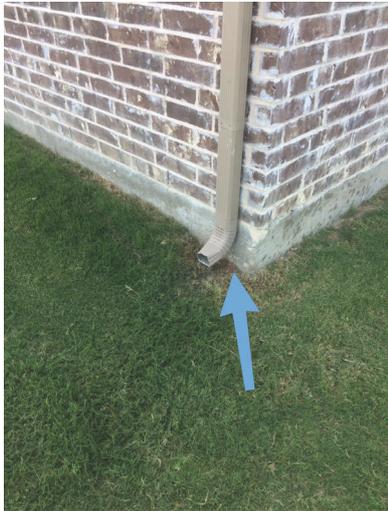
1: Splash Blocks Missing/Damaged

One or more splash blocks are missing or damaged at downspouts. Splash blocks help absorb the force of the water exiting the downspout to help prevent erosion.

Recommendation: Recommended DIY Project

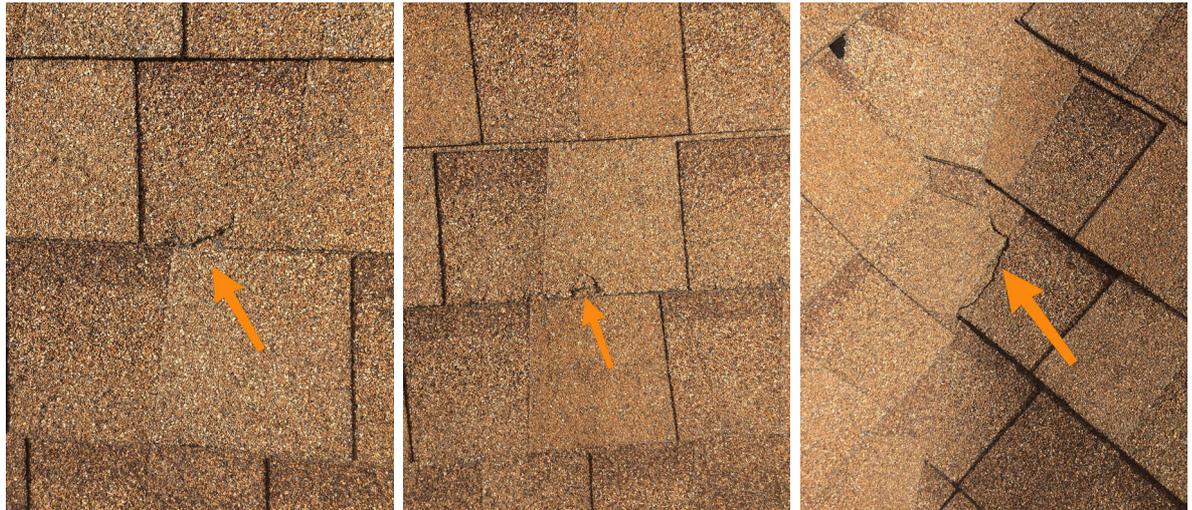
1: Coverings Damaged

Roof coverings exhibited general damage that could affect performance. Recommend a qualified roofer evaluate and repair.

Recommendation: Contact a qualified roofing professional.

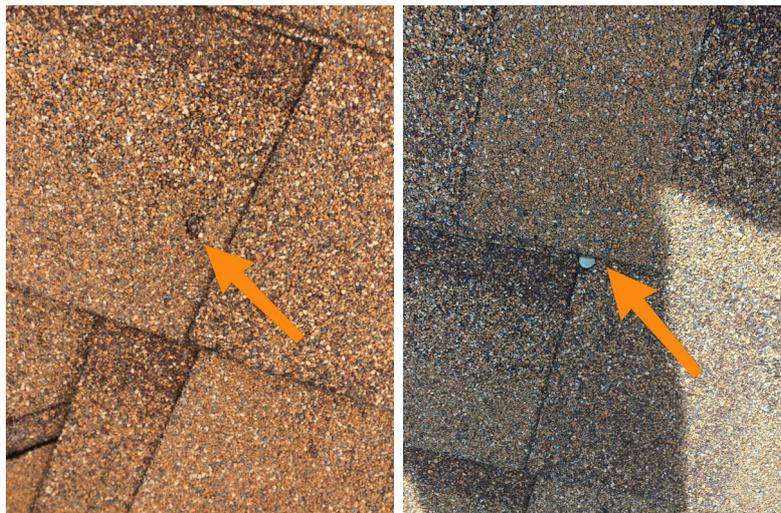
2: Fasteners Exposed

Under-driven or exposed nails or staples were found in areas of the roof coverings and is a potential source of water intrusion. Repair as needed.

Recommendation: Contact a handyman or DIY project

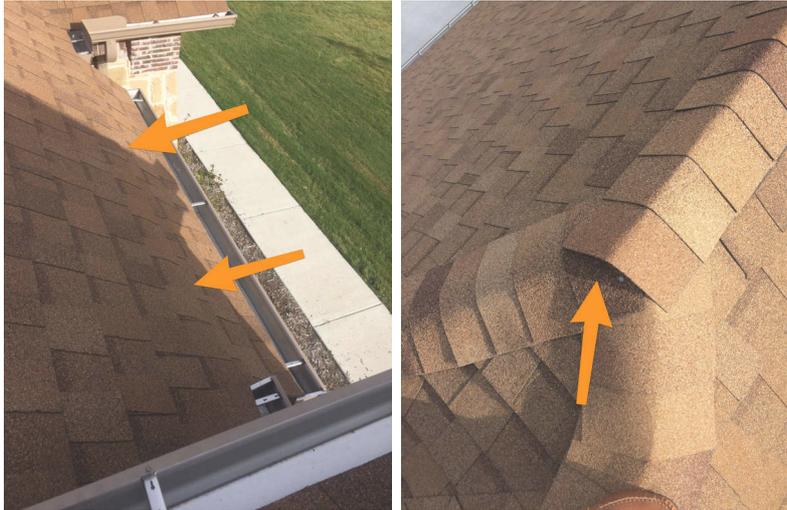
3: Installation Improper

This area of the roof coverings were installed with a uncommon practice. The drop in the roof structure design could lead to premature wear of shingles. Monitor or have A qualified contractor repair

Recommendation: Contact a qualified roofing professional.

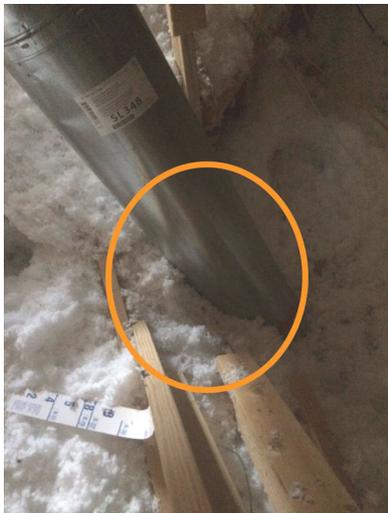
1: Insulation touching fireplace flue pipe

The insulation in attic is in contact with the fireplace flue pipe. There should be at least 2 inches of clearance around flu pipe from combustibles. Have a qualified contractor repair as needed

Recommendation: Contact a qualified professional.

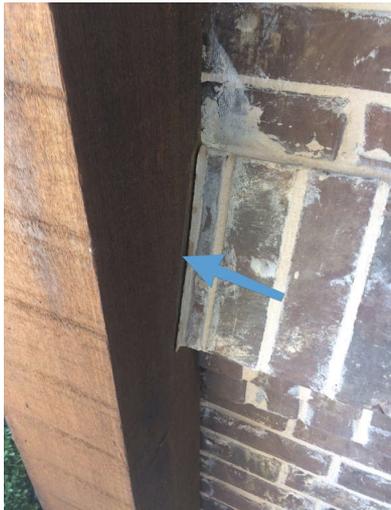
1: Exterior Caulking

One or more areas at the exterior such as around windows, doors, wood trim, expansion joints, and exterior penetrations require minor caulking improvements. This is a maintenance item that will need to be done periodically.

Recommendation: Recommended DIY Project

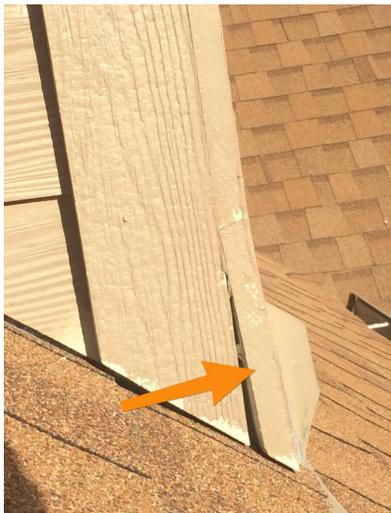
2: Trim piece broken

A piece of exterior trim is broken. It appears done during installation. Repair is needed.

Recommendation: Contact a qualified professional.

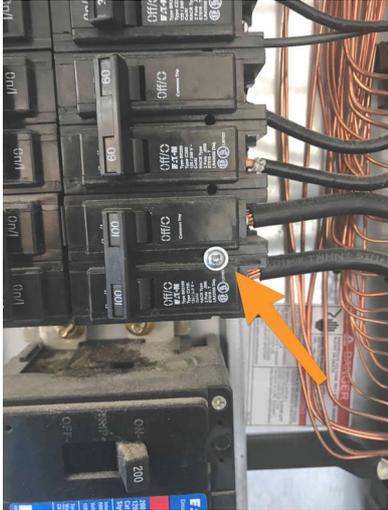
1: Screw in Breaker to Sub Panel

The breaker supplying sub panel had a screw set in the middle of breaker. This is not standard practice. Have a electrical contractor repair as needed

Recommendation: Contact a qualified professional.

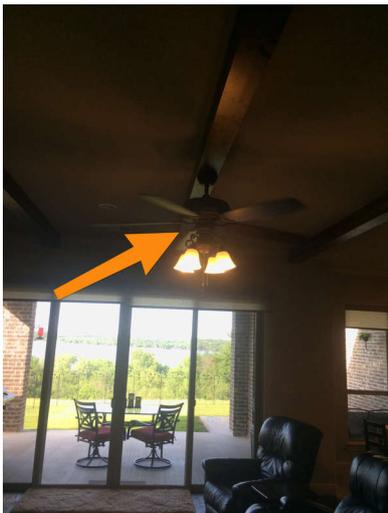
1: Ceiling Fan Controlled By Pull Chain Only

One or more ceiling fans are controlled by a pull chain only. Repair as needed.

Recommendation: Contact a qualified electrical contractor.

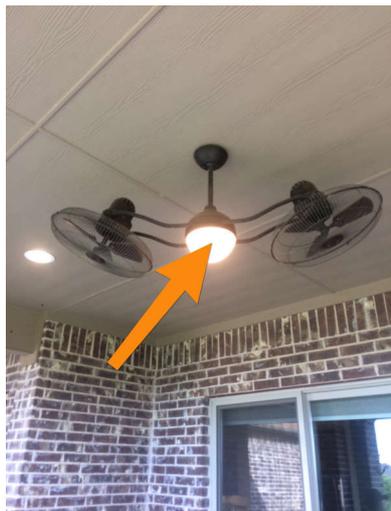
2: Ceiling Fan Inoperable

One or more ceiling fans do not work. Repair as needed.

Recommendation: Contact a handyman or DIY project

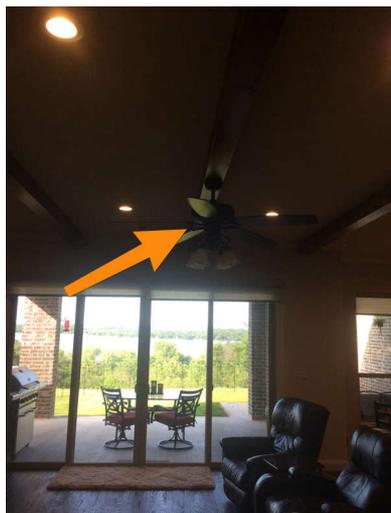
3: Ceiling Fan Wobbles

One or more ceiling fans wobble and may need balancing or replacement. Repair as needed.

Recommendation: Contact a handyman or DIY project

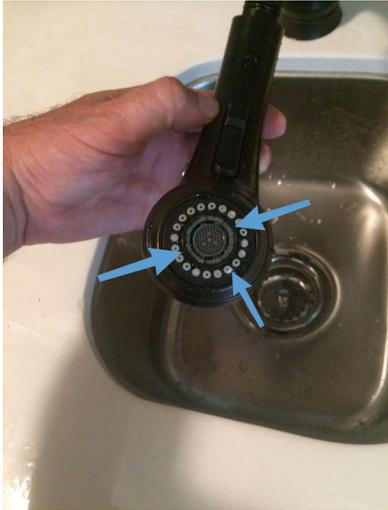
1: Aerator Clogged/Damaged
[🔧 Maintenance Item](#)
The aerator on or more faucets were clogged or damaged and need to be cleaned or replaced. This is a small repair. Repair as needed.

Recommendation: Contact a handyman or DIY project

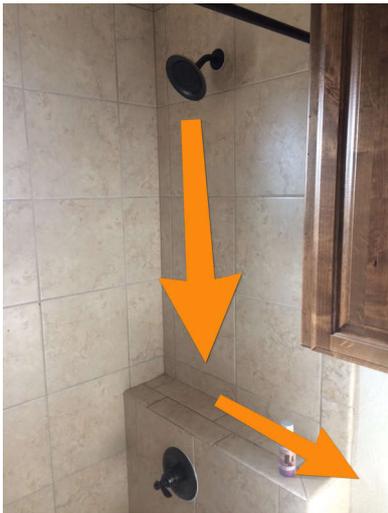
2: Shower Head Drips onto Ledge

The shower head drips onto the shower structure. It only drips shortly after the shower is turned off but the ledge that it drips onto could allow water to drip onto the bathroom. This is for your information.

Recommendation: Contact a handyman or DIY project

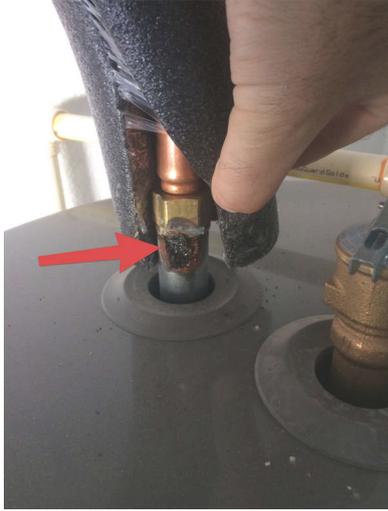
1: Corrosion

Corrosion was noted at one or more water heater joints or valves. There was moisture present at time of inspection. A licensed plumber should repair as needed.

Recommendation: Contact a qualified plumbing contractor.

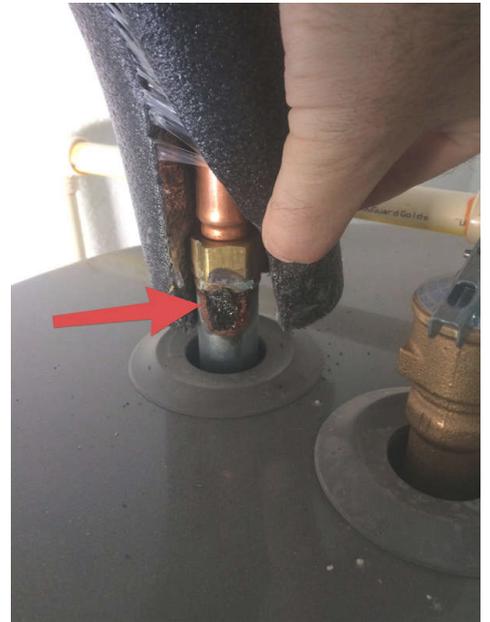
5.3.1 C. Water Heating
Equipment
CORROSION

Corrosion was noted at one or more water heater joints or valves. There was moisture present at time of inspection. A licensed plumber should repair as needed.

Contact a qualified plumbing contractor.
