## PROPERTY INSPECTION REPORT

404 Somewhere Dr  
Fort worth TX 76244

JUNE 18, 2019

**Cliff Snyder**

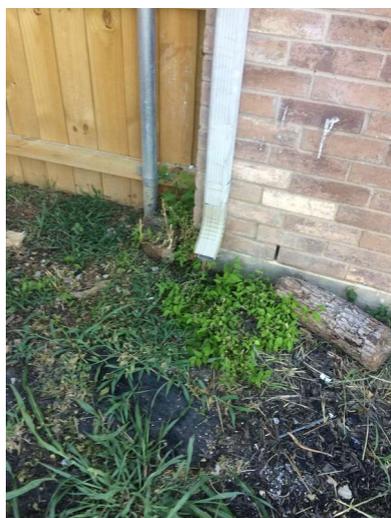
**3: Splash Blocks Missing/Damaged**

One or more splash blocks are missing or damaged at downspouts. Splash blocks help absorb the force of the water exiting the downspout to help prevent erosion.

Recommendation: Recommended DIY Project

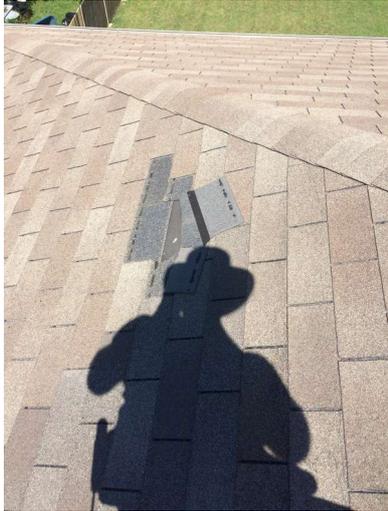
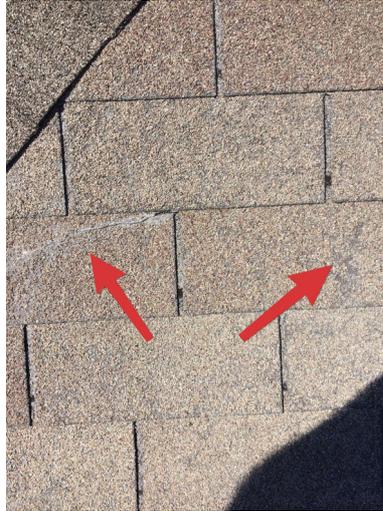
**1: Coverings Damaged**

Roof coverings exhibited general damage that could affect performance. Recommend a qualified roofer evaluate and repair.

Recommendation: Contact a qualified roofing professional.

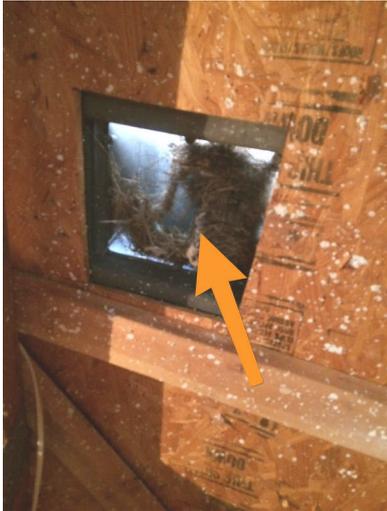
**1: Roof Vent Obstructed**

One or more roof vents are obstructed. A birds nest. A qualified contractor should repair as needed.

Recommendation: Contact a qualified professional.

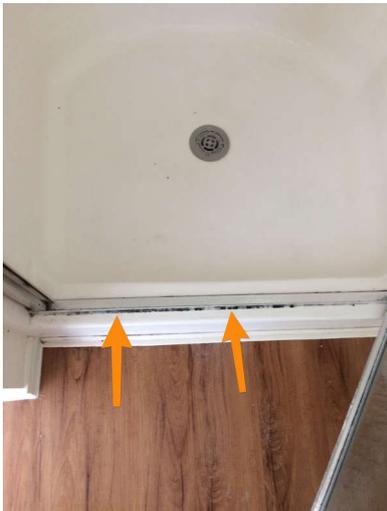
**1: Bath Grout/Caulk**

Grout and/or caulk improvements are needed at one or more wet locations. Microbial growth present in caulking. Repair as needed.

Recommendation: Contact a qualified professional.

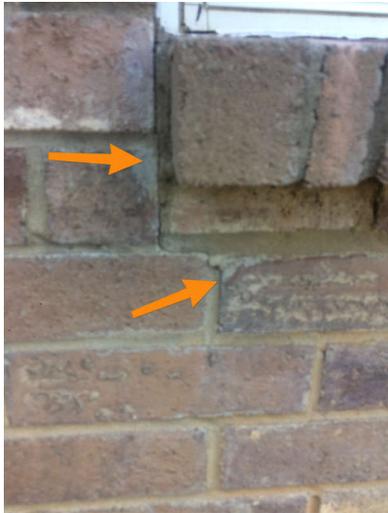
## 2: Brick/Mortar Separation Minor

Minor brick or mortar separations were noted. Recommend repair as needed to prevent further deterioration.

Recommendation: Recommended DIY Project

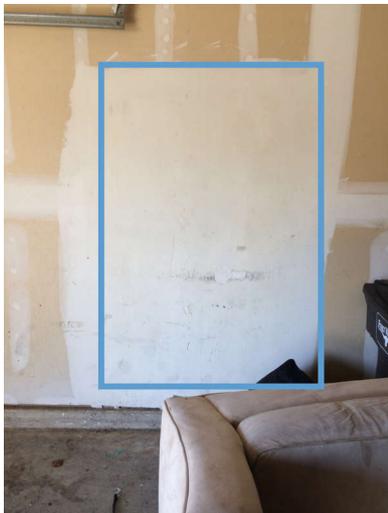
## 3: Repairs Noted

Signs of previous repairs were noted. Additional information should be obtained from the current owner.

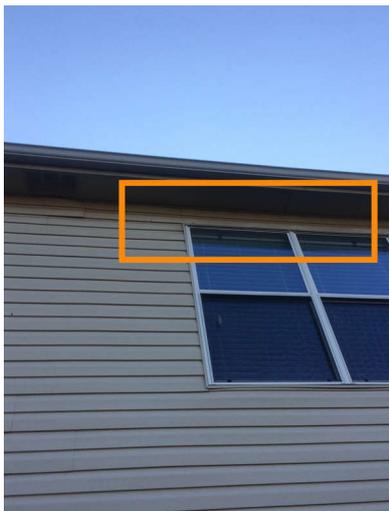
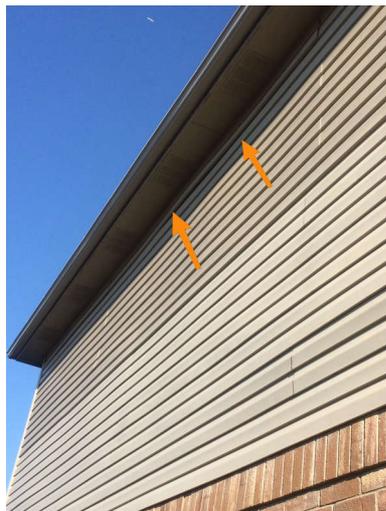
## 4: Walls - Exterior Covering Damaged/Deteriorated

One or more areas of the exterior cladding (brick, stone, siding, trim) was damaged or deteriorated. Further deterioration can occur if not corrected. Recommend repair by a qualified contractor.

Recommendation: Contact a qualified professional.

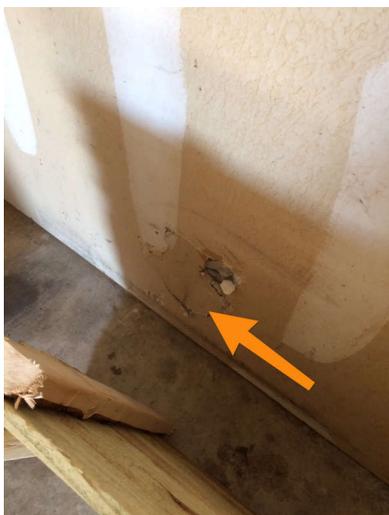
### 5: Walls - Interior Covering Damaged/Deteriorated

One or more areas of the interior walls were damaged or deteriorated. Recommend repair as needed.

Recommendation: Recommended DIY Project

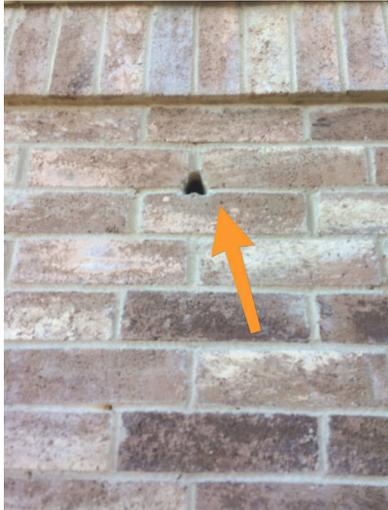
### 6: Hole in Exterior Brick

Hole is brick on exterior leading into garage. Repair as needed

Recommendation: Contact a qualified professional.

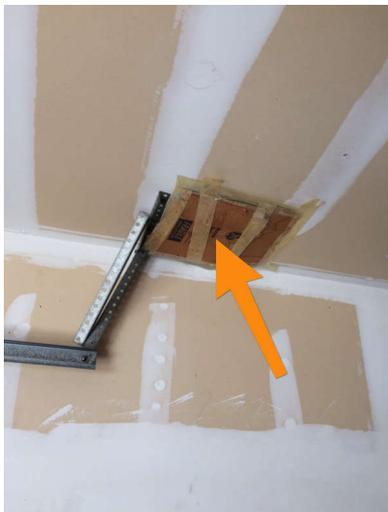
**1: Ceiling - Damage Minor**

Minor damage or deterioration to the ceiling was visible at the time of the inspection. Repair as needed.

Recommendation: Contact a qualified drywall contractor.

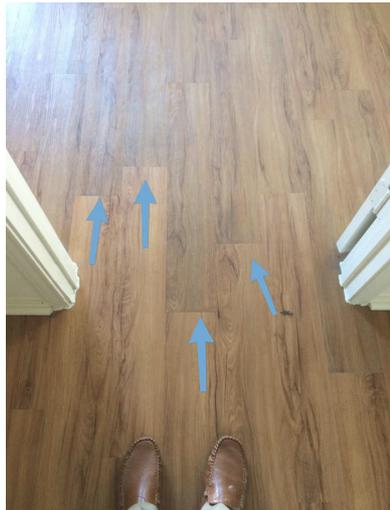
**2: Repairs Noted**

One or more repairs were noted. Additional information should be obtained from the current owner.

Recommendation: Contact a qualified professional.

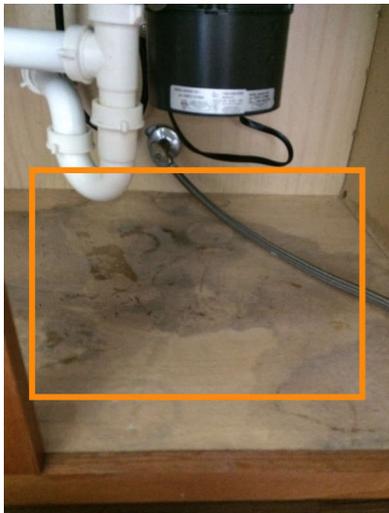
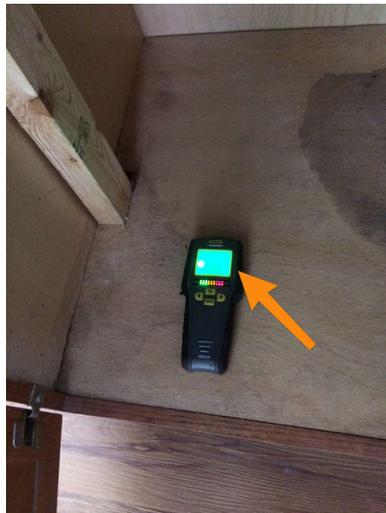
**1: Base Cabinetry Damaged**

The base cabinetry under one or more sinks has water damage and is structurally unsound and currently showing high levels of moisture. Recommend repair as necessary.

Recommendation: Contact a qualified cabinet contractor.

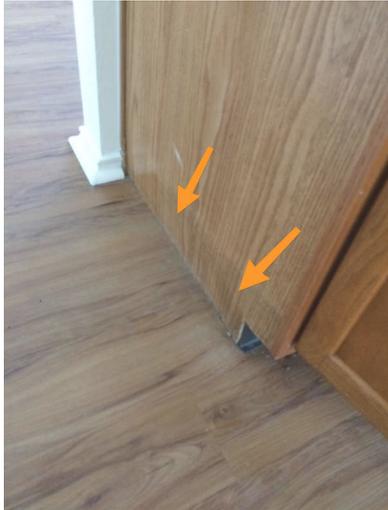
**2: Cabinetry Damaged**

One or more areas of cabinetry were water damaged.

And currently wet. Repair as needed.

Recommendation: Contact a qualified professional.

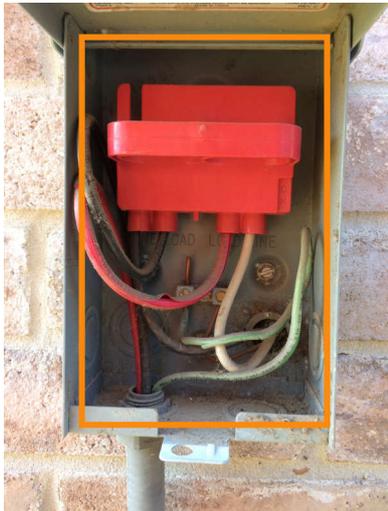
**1: A/C Panel Cover Missing**

The disconnect for the outside A/C unit is missing a cover. Repair as needed.

Recommendation: Recommended DIY Project

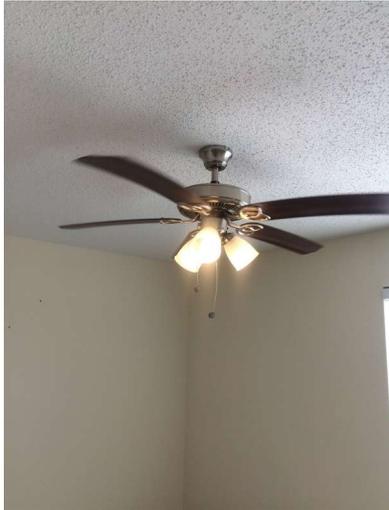
**2: Ceiling Fan Controlled By Pull Chain Only**

One or more ceiling fans are controlled by a pull chain only. Repair as needed.

Recommendation: Contact a qualified electrical contractor.

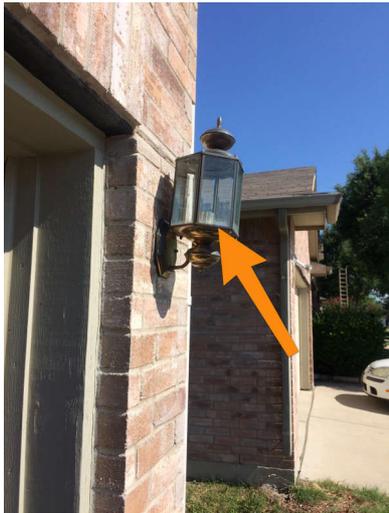
**3: Light Inoperable**

One or more light fixtures were not operating. A new light bulb, repair, or replacement is possibly needed.

Recommendation: Recommended DIY Project

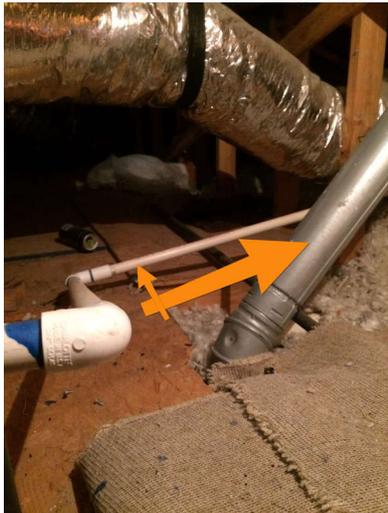
**1: Drain Discharge Improper**

One or more cooling systems have a secondary condensation drain line plumbed improper. Have a qualified contractor repair as needed

Recommendation: Contact a qualified HVAC professional.

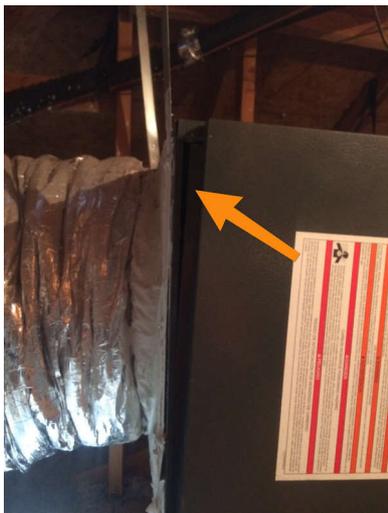
**2: Air Handler Box not Sealed**

The air handler in attic has a cover that is installed wrong do to a mounting screw used for hanger. Repair as needed

Recommendation: Contact a qualified professional.

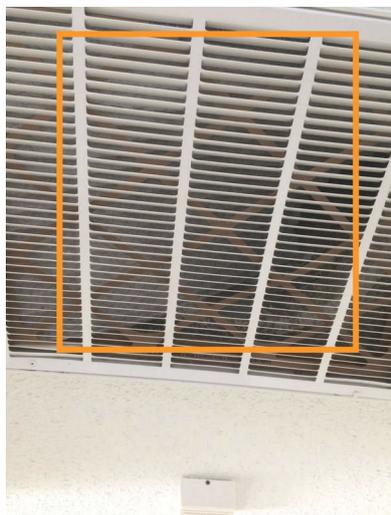
**1: Filter is Damaged**

Filter is damaged. This can allow dirt and dust to enter A/C system. This can block the coils and decrease cooling efficiency.

Recommendation: Contact a qualified professional.

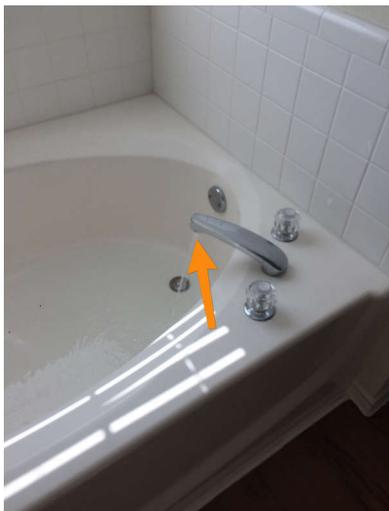
**1: Aerator Screen Requires Cleaning/Replacement**

One or more fixtures spray water onto adjacent surfaces indicating that the aerator screen needs to be cleaned or replaced.

Recommendation: Contact a handyman or DIY project

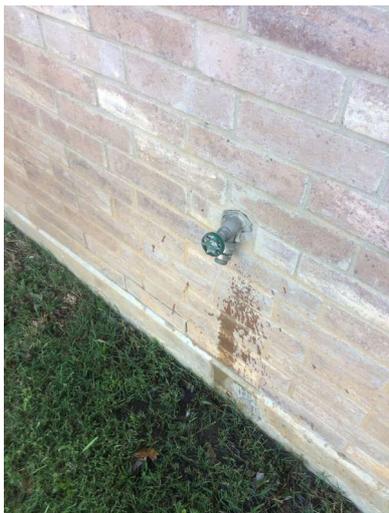
## 2: Faucet Leaks

One or more faucets leaked when operated. Repair as needed.

Recommendation: Contact a handyman or DIY project

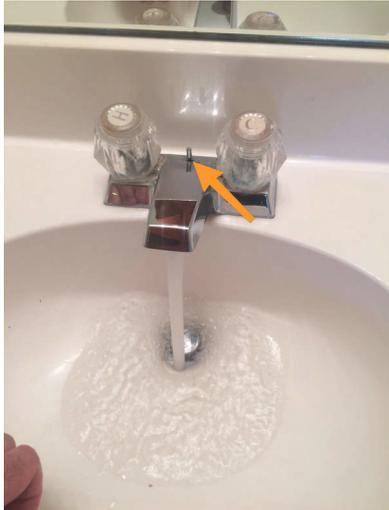
### 1: Drain Missing

One or more drains are missing. Recommend repair by a licensed plumber.

Recommendation: Contact a qualified plumbing contractor.

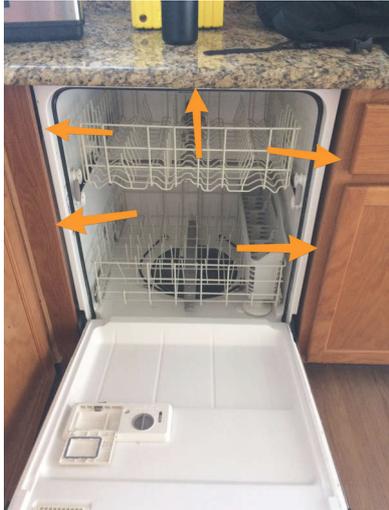
**1: Loose at Countertop**

The dishwasher is loose and should be secured to the underside or side of the cabinetry. Repair as necessary.

Recommendation: Recommended DIY Project

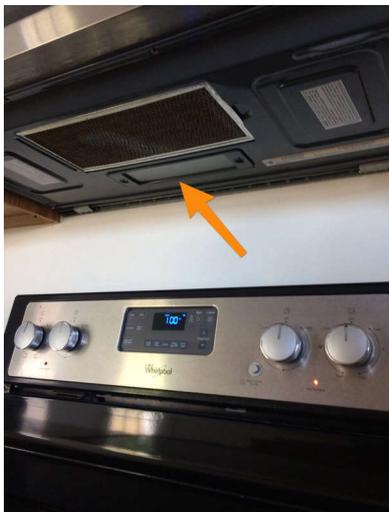
The microwave light does not work (try bulb first). Repair is recommended.

Recommendation: Recommended DIY Project

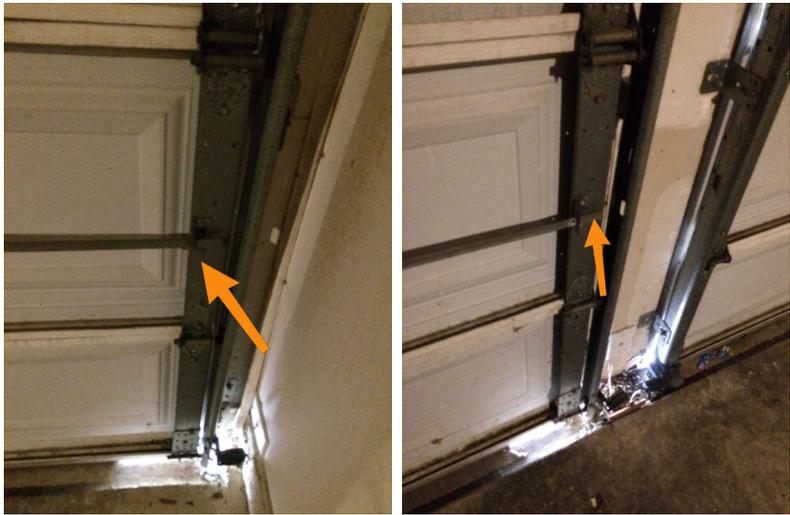
Garage door locks should be removed or disabled when automatic openers are installed. Accidental damage to the garage door can occur when the locks are engaged and the automatic opener activates, This is a small repair. Repair is recommended.

Recommendation: Recommended DIY Project

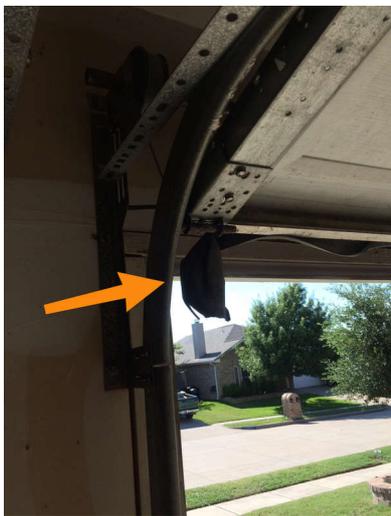
**2: Weather Stripping Missing/Deteriorated**

The weather stripping at the bottom of the garage door is missing, damaged, or deteriorated. Repair is recommended.

Recommendation: Recommended DIY Project

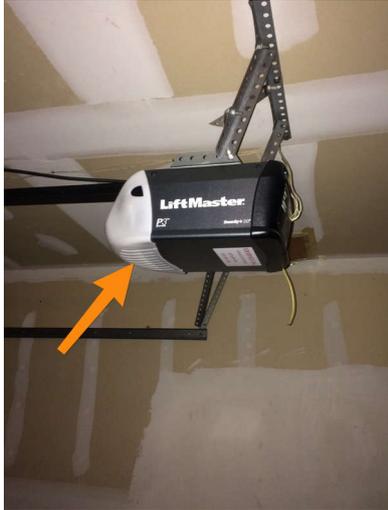
**3: Light not working**

Light not working on garage door opener. Repair as needed

Recommendation: Contact a qualified professional.

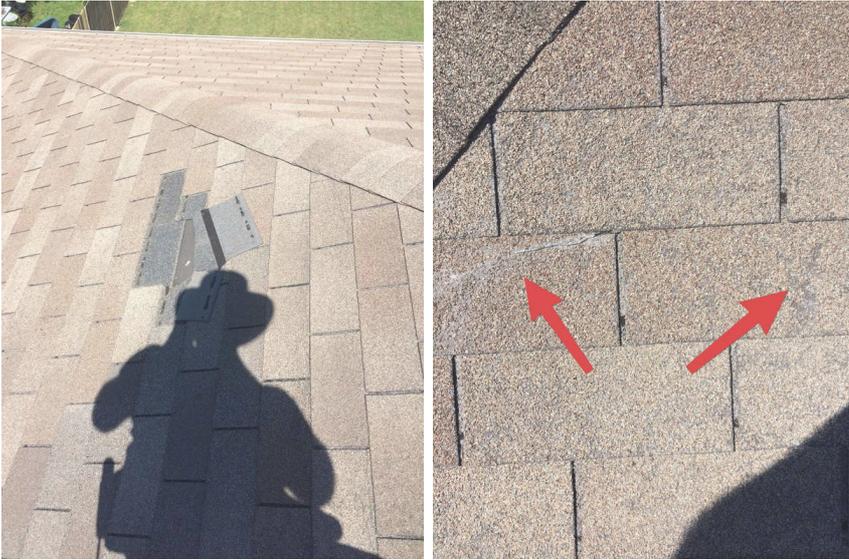
#### **COVERINGS DAMAGED**

Roof coverings exhibited general damage that could affect performance. Recommend a qualified roofer evaluate and repair.

Recommendation  
Contact a qualified roofing professional.

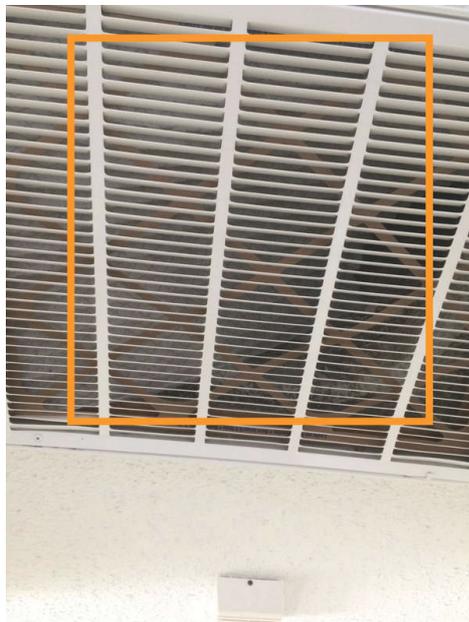
### **FILTER IS DAMAGED**

Filter is damaged. This can allow dirt and dust to enter A/C system. This can block the coils and decrease cooling efficiency.

Contact a qualified professional.
