PROPERTY INSPECTION REPORT

404 Somewhere Dr
Weatherford TX 76088

Marcia Client
JUNE 15, 2019

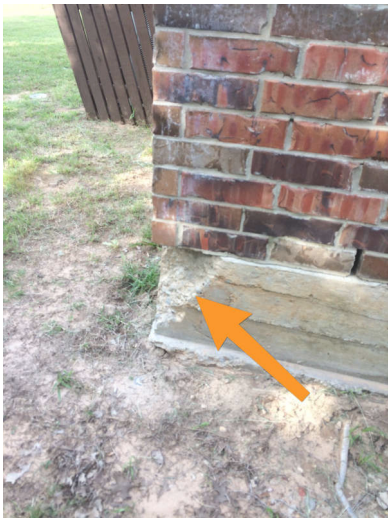
- ☒☐☐☒A. Foundations
- Type of Foundation(s): Slab on Grade
- Method Used To Observe Crawlspace: No crawlspace
- Location of Crawlspace Access: Not Applicable
- Foundation Performing As Intended:
- It is the opinion of the inspector that at the time of inspection the foundation was performing its intended function of supporting the structure.
- 1: Corner Pop (Repair)
- Deficient
- One or more corner pops exists that need repair to help support the brick or stone veneer. Repair as needed.
- Recommendation: Contact a handyman or DIY project

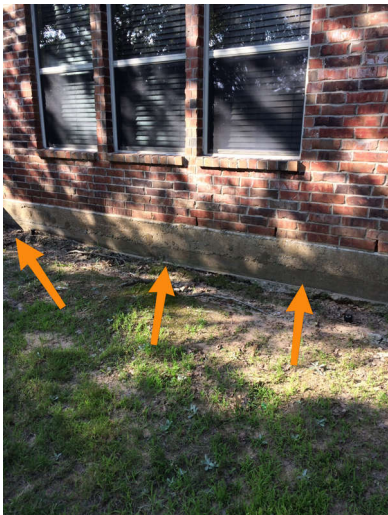
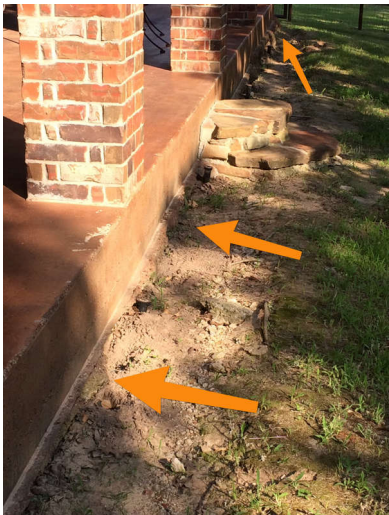
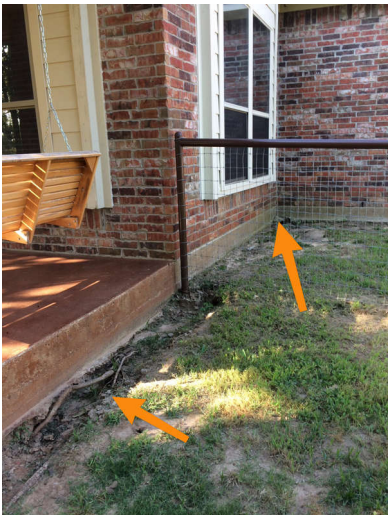
- ☒☐☐☒B. Grading and Drainage
- 1: Erosion Noted
- Deficient
- Erosion was noted in one or more areas around the foundation. Repair as needed.
- Recommendation: Recommended DIY Project

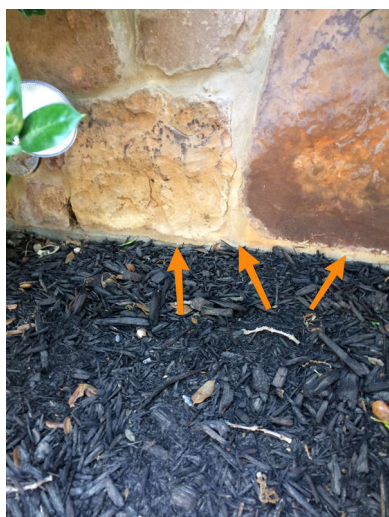
2: Landscape High

Front flower bed

The landscaping in areas is near or above the top of the foundation. This can allow for water intrusion in heavy rain. Adequate ground clearances (4" for masonry or 6" for siding or stucco) are recommended to prevent deterioration and water intrusion. Recommend adjustment to the grading or landscaping as needed.

Recommendation: Contact a qualified landscaping contractor

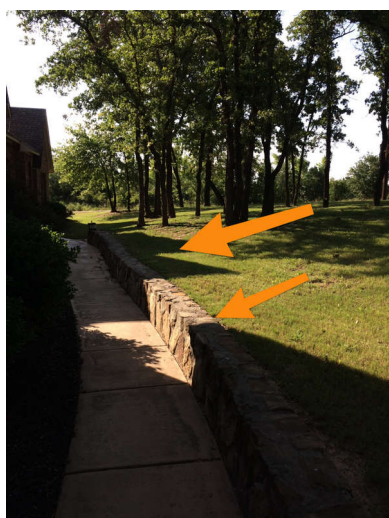
3: Negative Slope

Grading is sloping towards the home in some areas. This could lead to water intrusion and foundation issues. A qualified landscaper or foundation contractor should regrade so water flows away from home.

Recommendation: Contact a qualified landscaping contractor

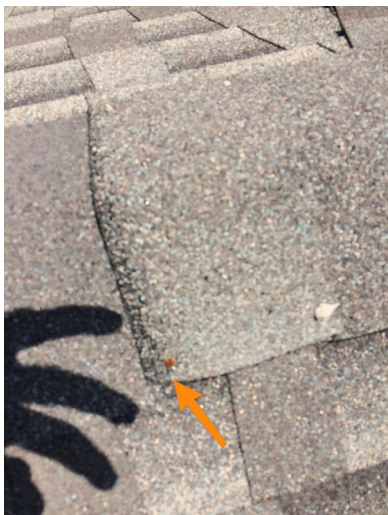
1: Fasteners Exposed

Under-driven or exposed nails or staples were found in areas of the roof coverings and is a potential source of water intrusion. Repair as needed.

Recommendation: Contact a handyman or DIY project

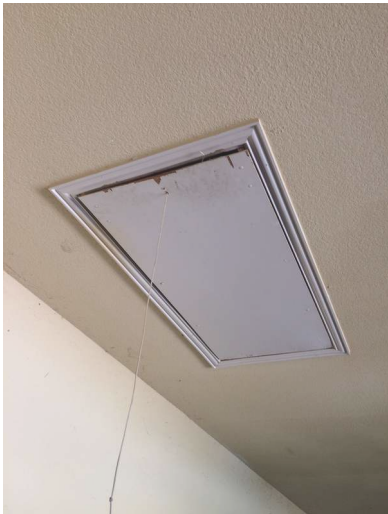
1: Attic Stairs Not Sealing Tightly

The attic stairs did not seal tightly. Repair as needed.

Recommendation: Contact a handyman or DIY project

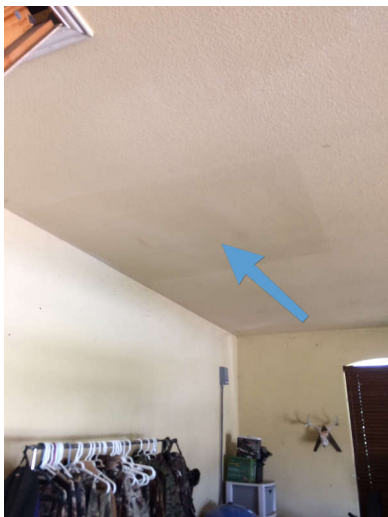
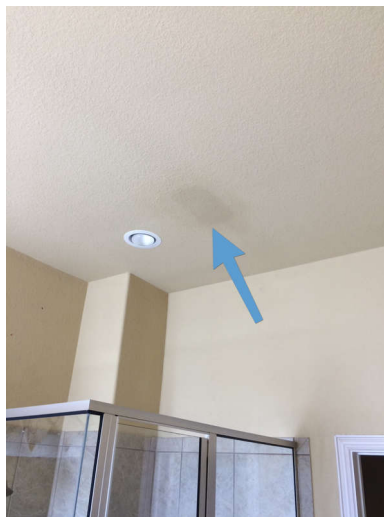
1: Repairs Noted

One or more repairs were noted. Additional information should be obtained from the current owner.

Recommendation: Contact a qualified professional.

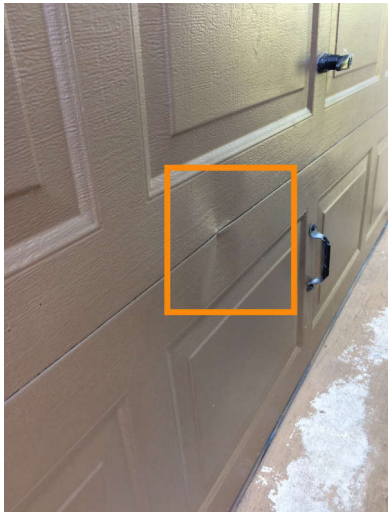
1: Door Damaged

Garage 1, master 1,

One or more door were damaged. Master bedroom doors to patio had did chew marks. Repair as needed.

Recommendation: Contact a qualified professional.

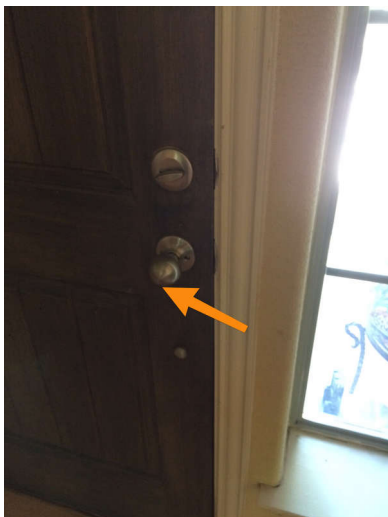
2: Lock Not Working Properly

One or more doors did not lock properly. Repair as needed.

Recommendation: Contact a handyman or DIY project

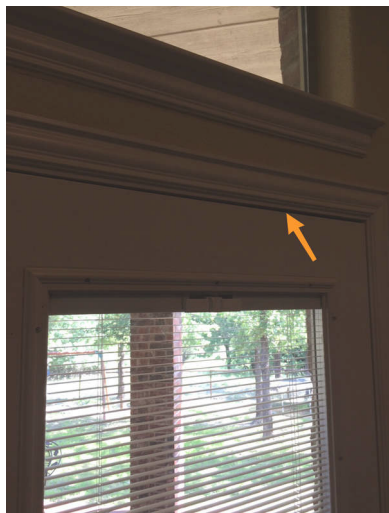
3: Out of Square

Back door

One or more doors did not fit the opening properly (out of square). Recommend repair.

Recommendation: Contact a qualified door repair/installation contractor.

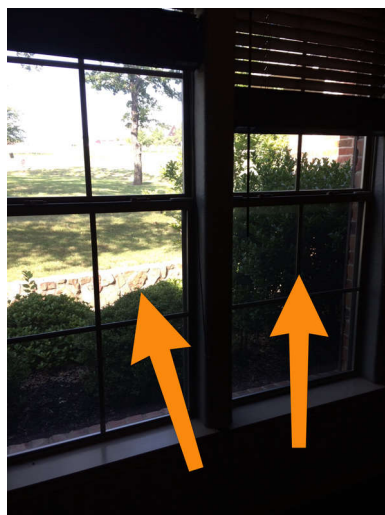
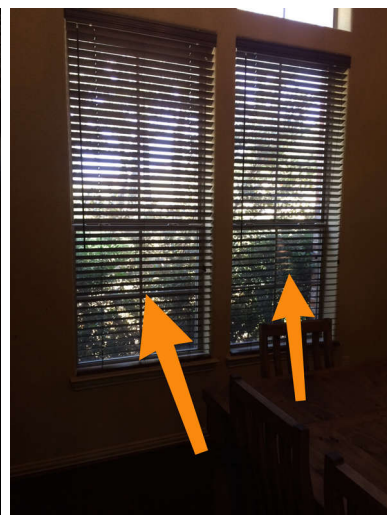
1: Difficult to Operate

One or more windows were difficult to open or close. A qualified contractor should evaluate and make any needed repairs.

Recommendation: Contact a qualified window repair/installation contractor.

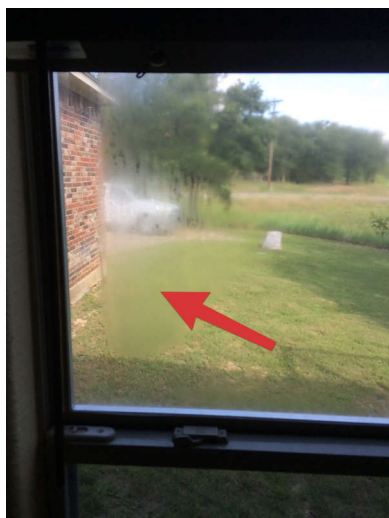
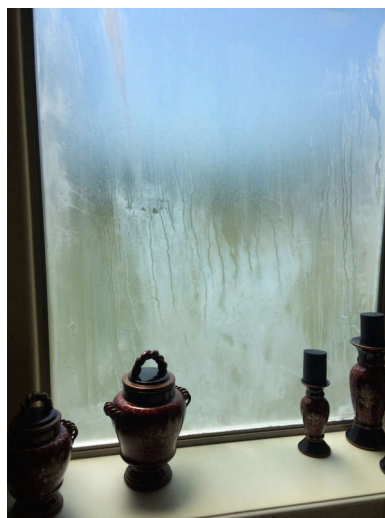
2: Seal Failed

Dinning 1, mater bath 1, front right bedroom 1, laundry 1,

One or more windows were cloudy or display other evidence of broken seals. Seals between window panes offer some insulation benefits. A qualified contractor should evaluate all windows in these locations and repair as needed.

Recommendation: Contact a qualified window repair/installation contractor.

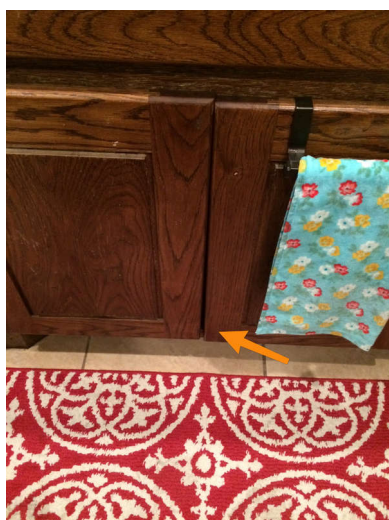
2: Cabinet Doors Out of Alignment

One or more cabinet doors are out of alignment. Repair as needed

Recommendation: Contact a handyman or DIY project

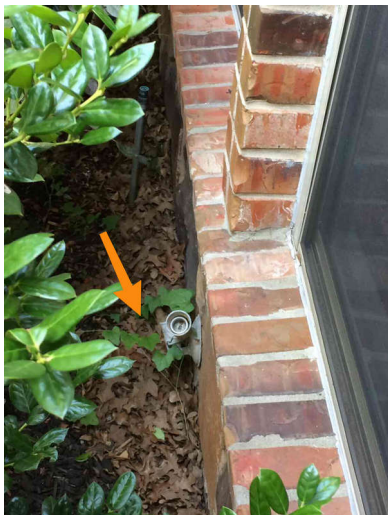
2: Light Inoperable

One or more light fixtures were not operating. A new light bulb, repair, or replacement is possibly needed.

Recommendation: Recommended DIY Project

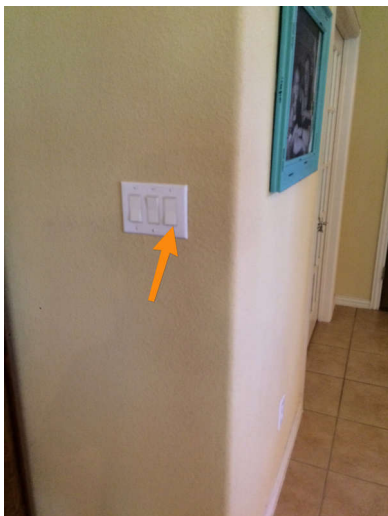
4: Wall Switches 3-Way Improper

Living room

One or more wall switches do not operate as true 3 way switches. Living rooms lights in picture should work with back door switch but do not. Recommend repair by a licensed electrician.

Recommendation: Contact a qualified electrical contractor.

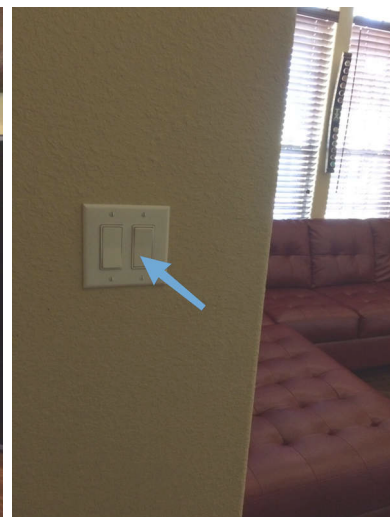
5: Wall Switches Unknown Function

The function of one or more wall switches were unable to be determined. Recommend obtaining additional information form the current owner or repair by a licensed electrician.

Recommendation: Contact a qualified electrical contractor.

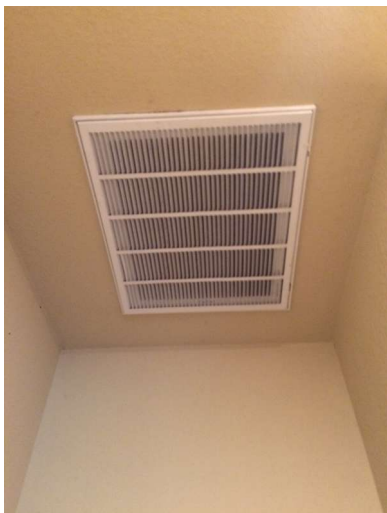
Filter Dirty:

One or more filters are dirty and should be replaced. Replace as needed.

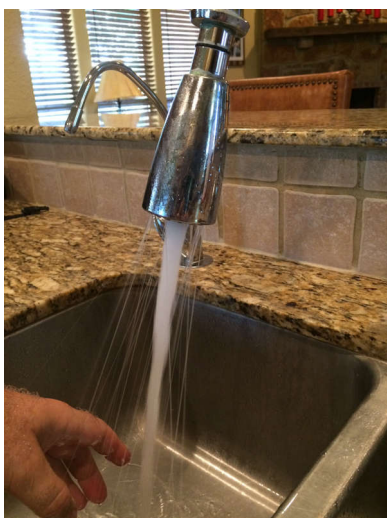
One or more sprayers are not working properly. Recommend repair as needed.

Recommendation: Contact a qualified professional.

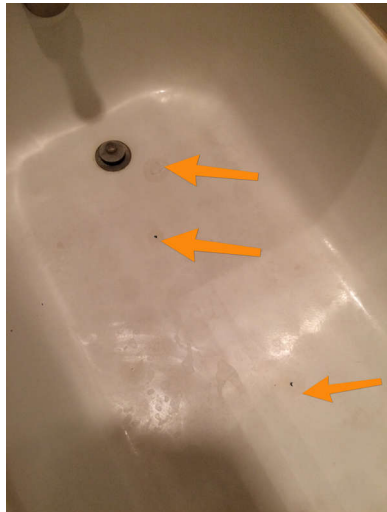
4: Tub Damaged (Repair)

One or more tub surfaces are damaged. Recommend repair by a qualified contractor.

Recommendation: Contact a qualified professional.

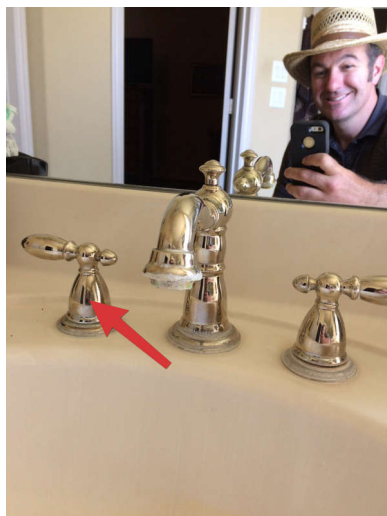
5: Fixture Not Producing Water

One or more fixtures did not produce water. A licensed plumber should evaluate further and make any needed repairs.

Recommendation: Contact a qualified plumbing contractor.

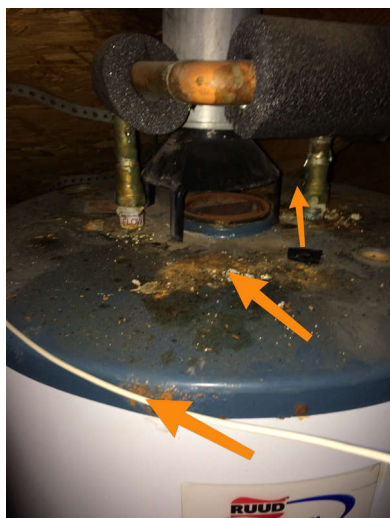
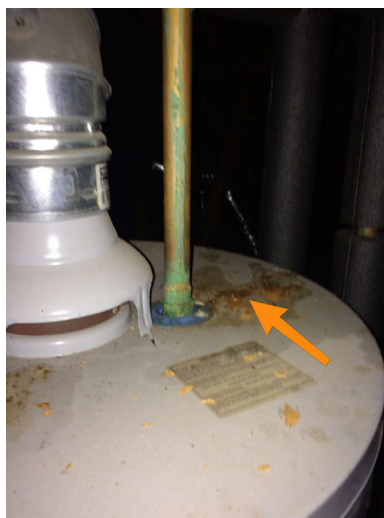
1: Corrosion At Water Heater

One or more plumbing lines on water heater are showing signs of corrosion. Have a qualified plumbing contractor evaluate as needed

Recommendation: Contact a qualified professional.

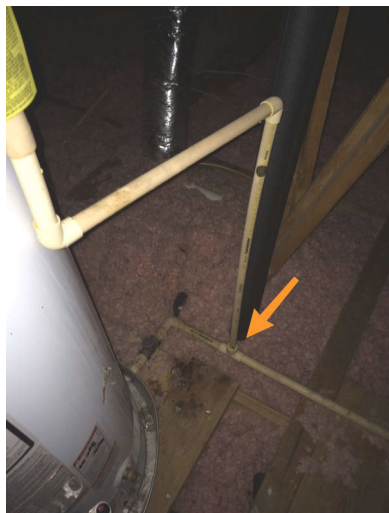
2: TPRV Terminates To Drainage System

The existing piping for the temperature and pressure relief valve (TPRV) discharge pipe on the water heater is connected directly to the drainage system which is not allowed. A blockage could prevent the TPRV from discharging properly. Repair is recommended.

Recommendation: Contact a qualified plumbing contractor.

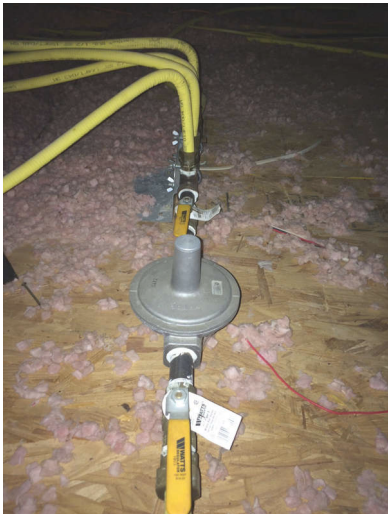
1: Bonding Not Present (CSST)

The home was noted to have CSST (Corrugated Stainless Steel Tubing) installed for the gas supply which requires bonding to help safeguard against potential fire hazards. The inspector was unable to determine if or where bonding may have occurred and recommends further evaluation and repair by a licensed electrical contractor.

Recommendation: Contact a qualified electrical contractor.

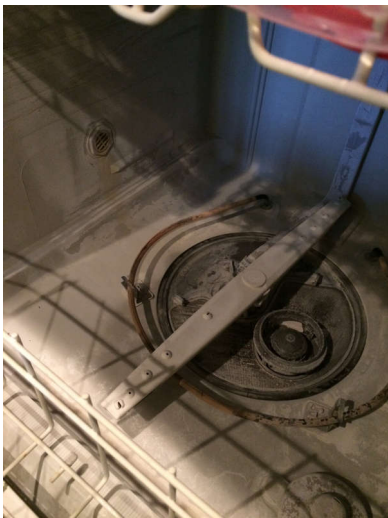
The dishwasher was coated with mineral deposits and should be cleaned as needed.

Recommendation: Recommended DIY Project

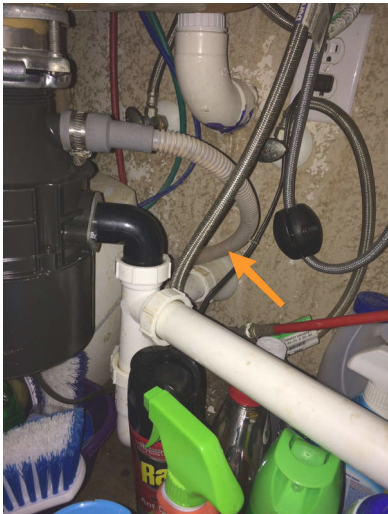
2: High Loop Missing

The dishwasher does not have an air gap installed or proper "high loop". Adjusting the drain hose to form a high loop to help prevent backflow of water and debris into the dishwasher is recommended.

Dishwasher High Loop Drain Line

Recommendation: Recommended DIY Project

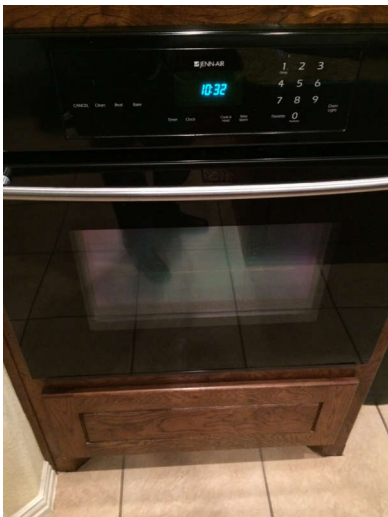
The oven did not work when tested. A qualified contractor should evaluate the oven units and make any needed repairs.

Recommendation: Contact a qualified appliance repair professional.

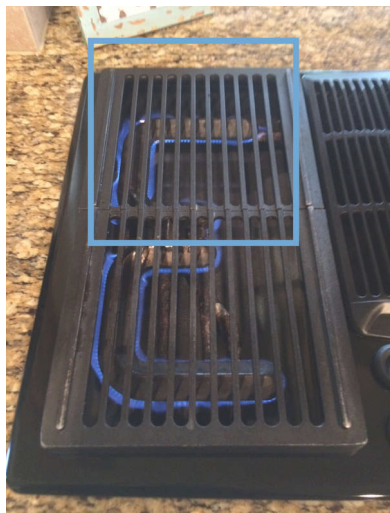
2: Grill burner flame slow

One half of burner took a minute to fully ignite. Monitor

Recommendation: Contact a qualified professional.

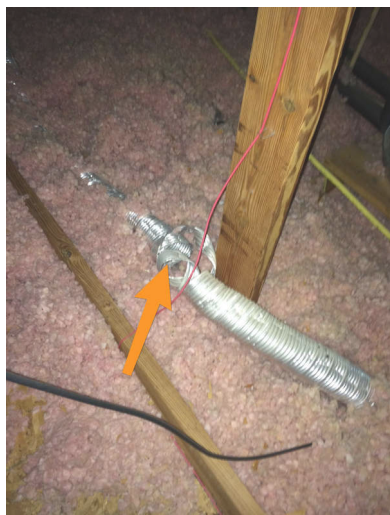
One or more exhaust fans vent into the attic instead of the outdoors which can sometimes cause moisture that can lead to condensation or mold. A qualified contractor should re-route the exhaust duct so that it terminates to the exterior.

Recommendation: Contact a qualified professional.

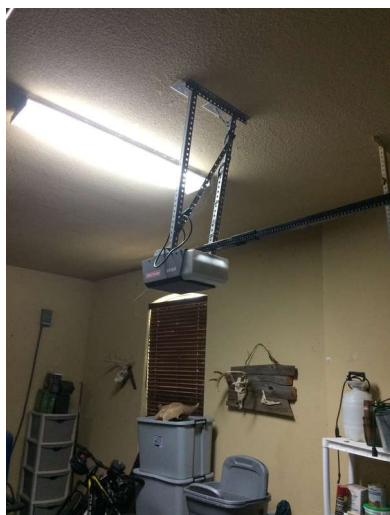
Garage door opener not plugged in:

The smal garage door opener was not plugged in at ceiling and could not be tested.

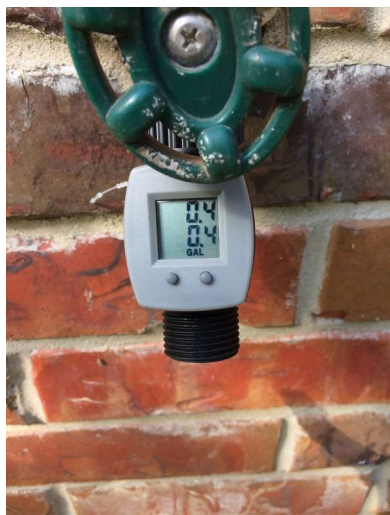
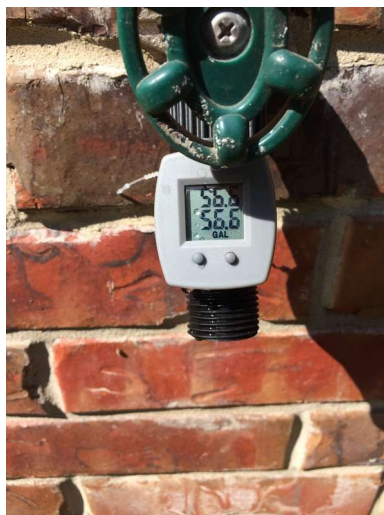
Ran water for 45 minutes :

Though water supply quantity and supply cannot be guaranteed water was run continuously for 45 minutes. This is in conjunction with testing all water features in home.

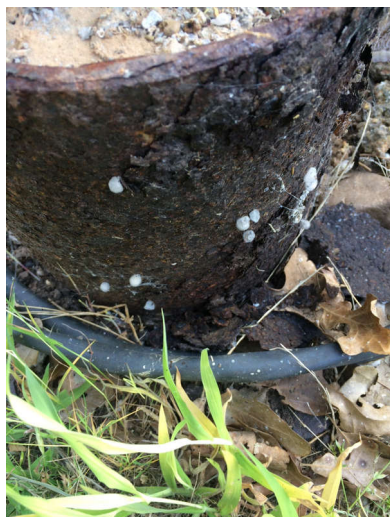
1: Rust/Corrosion

water Well casing is rusted. Due to being subjected to surface water. No permanent protective barrier installed. Repair as needed

Recommendation: Contact a qualified professional.

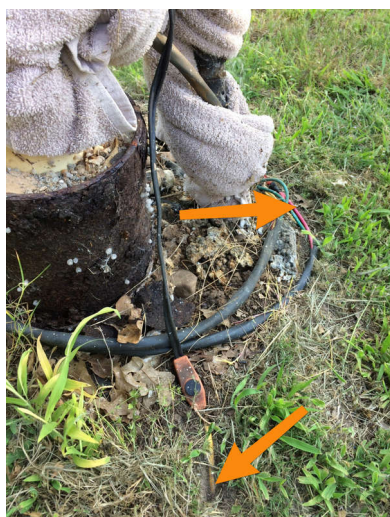
2: Well pump electrical

Well pump electrical wires are exposed to ground water and the elements. A permanent well pit or protective casing should be installed. Power supply line should be buried

Recommendation: Contact a qualified professional.

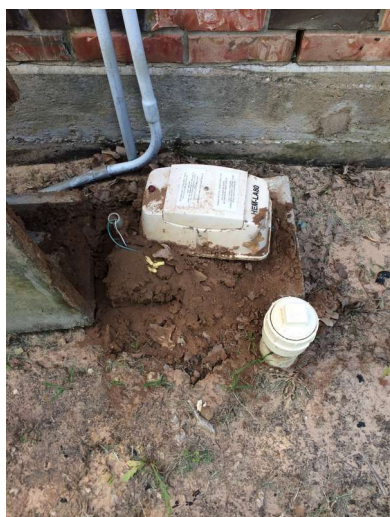
Fire ants were present at septic aerator pump. Reapair as needed

Recommendation: Contact a qualified professional.

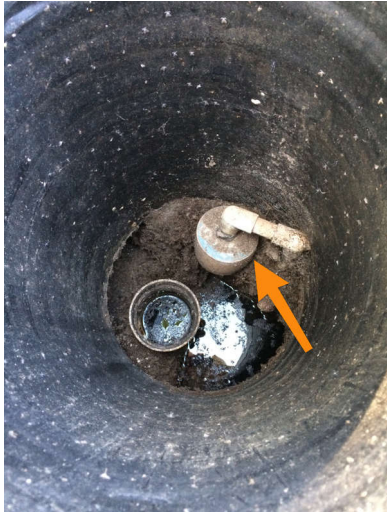
2: Air leaking from Pump plumbing

The aerator plumbing to solids tank is leaking air. Have a qualified septic contractor evaluate and reappear as needed.

Recommendation: Contact a qualified professional.

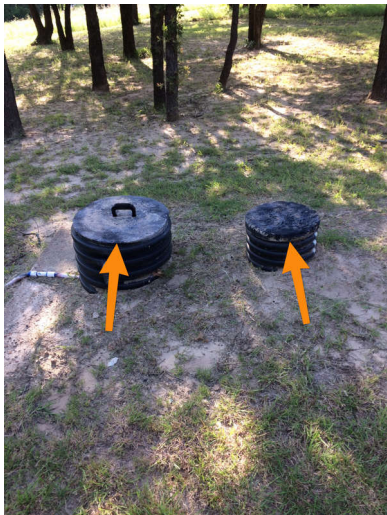
3: Septic tanks do not have safety lids

Septic tanks do not have lids attached with screws or safety latches. Repair as needed

Recommendation: Contact a qualified professional.
