INVESTIGATOR HOME INSPECTIONS

PROPERTY INSPECTION REPORT FORM

<i>Name of Client</i>	06/13/2025 1:00 pm
Springtown, TX 76082	<i>Date of Inspection</i>
<i>Address of Inspected Property</i>	
Cliff Snyder	Pro. Real Estate Inspector TREC # 23321
<i>Name of Inspector</i>	<i>TREC License #</i>
<i>Name of Sponsor (if applicable)</i>	<i>TREC License #</i>

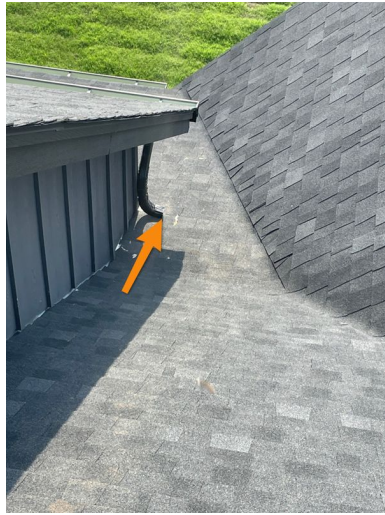
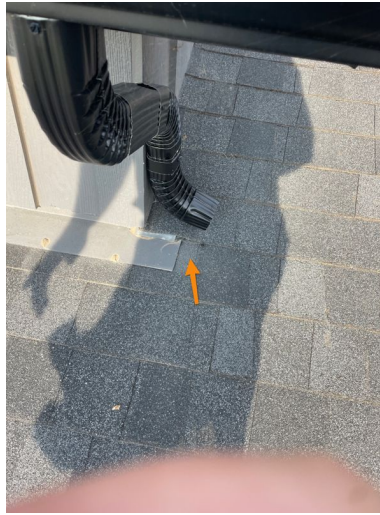
1: Flashing Loose/Missing/Damaged

Flashing was loose, missing, or damaged. A roofing contractor should evaluate the flashing details and make any needed repairs.

Recommendation: Contact a qualified roofing professional.

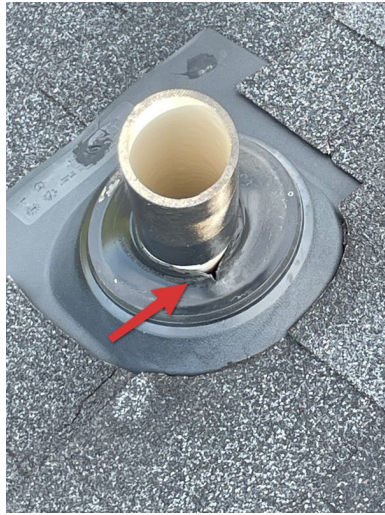
2: Non caulked/ exposed nails present

Non caulked / exposed nails present at roof vents and ridge caps. These are a source of potential water intrusion. Recommend having a qualified roofing contractor evaluate and repair

Recommendation: Contact a qualified professional.

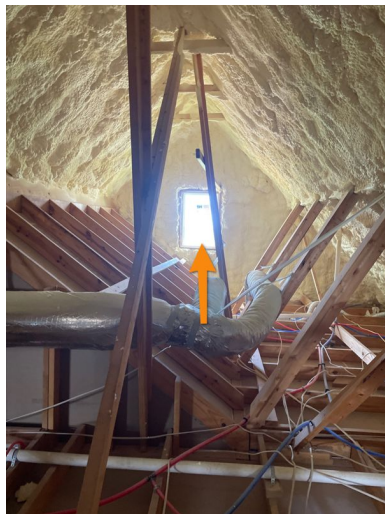
3: Spray Foam insulation has a hole cut into a unconditioned space

This defeats the purpose of a Spray Foam attic as it is no longer a sealed area. Have a qualified Spray Foam installation installer evaluate and repair any issues with the Spray Foam attic listed and not listed.

Recommendation: Contact a qualified professional.

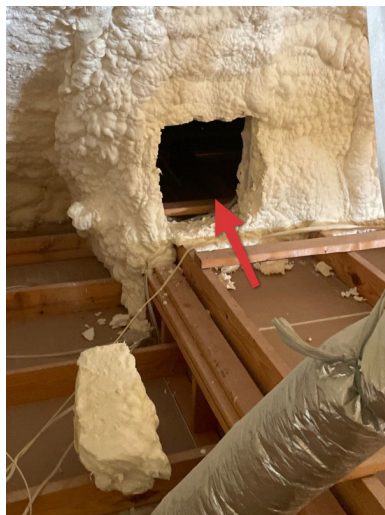
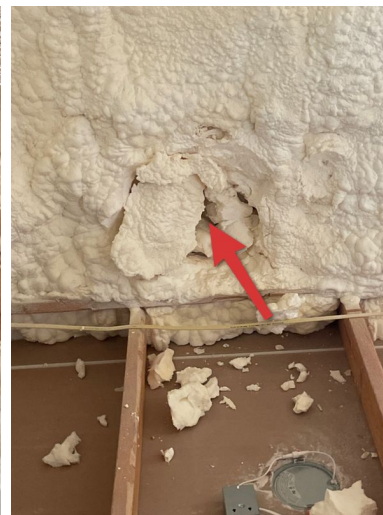
4: Roof strut is not Installed in a proper location

The roof strut should sit on top of loadbearing walls. Pictured roof strut is sitting a top a spliced 2 x 6 between two walls. This could cause sagging overtime. Recommend a qualified framing contractor evaluate and repair any issues with roof framing

Recommendation: Contact a qualified professional.

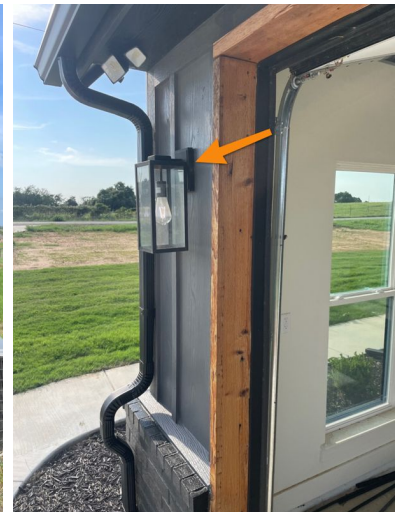
3: Exterior Paint/Stain Failing Minor

Minor areas of failing paint or stain were noted around the exterior . Recommend prep, prime, and paint as necessary.

Recommendation: Contact a qualified painting contractor.

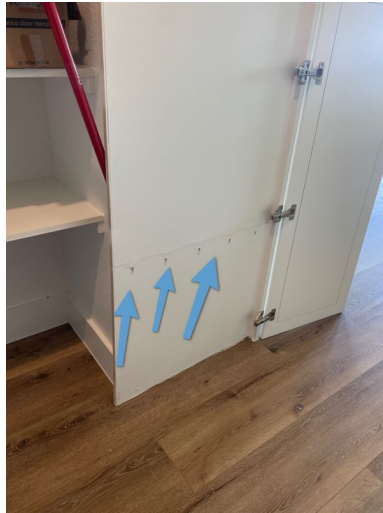
Pantry

5: Walls - Interior Covering Damaged/Deteriorated

One or more areas of the interior walls were damaged or deteriorated. Recommend repair as needed.

Recommendation: Recommended DIY Project

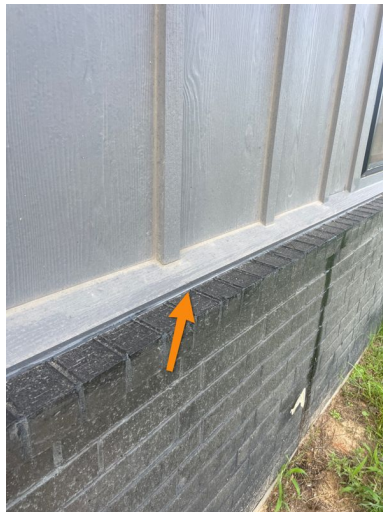
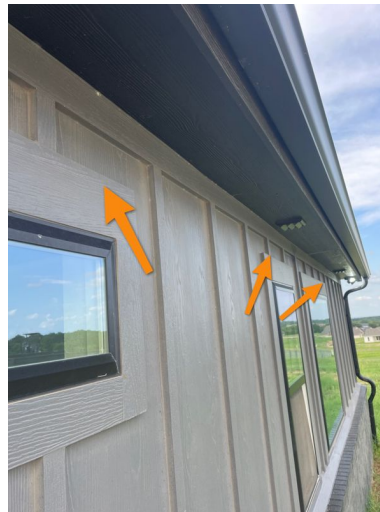
6: Improper flashing at one or more areas on exterior siding

Improper flashing at one or more areas on exterior siding. The manufacture of the siding requires a flashing in these areas. This can allow water to enter behind the siding. Recommend a qualified siding installer evaluate and make any need the repairs to the exterior siding

Recommendation: Contact a qualified professional.

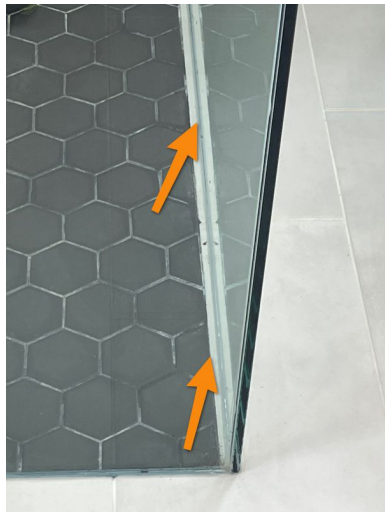
7: Shower enclosure is offset from shower tile

This will allow water to sit on an sloped area. recommend repair as needed

Recommendation: Contact a qualified professional.

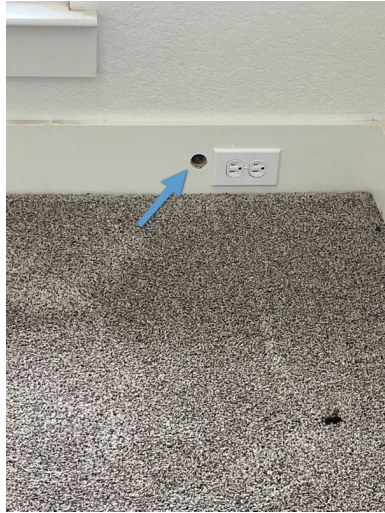
1: Floors - Baseboards Missing/Damaged

The baseboards are missing or damaged in one or more areas. Recommend repair as necessary.

Recommendation: Contact a qualified professional.

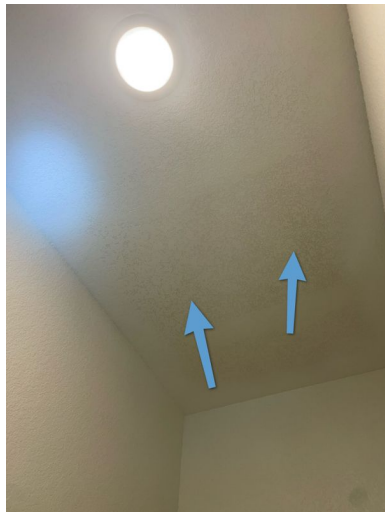
2: One or more areas of ceiling paint damage

One or more areas of ceiling paint damaged or not properly finished. Had a qualified contractor evaluate and repair

Recommendation: Contact a qualified professional.

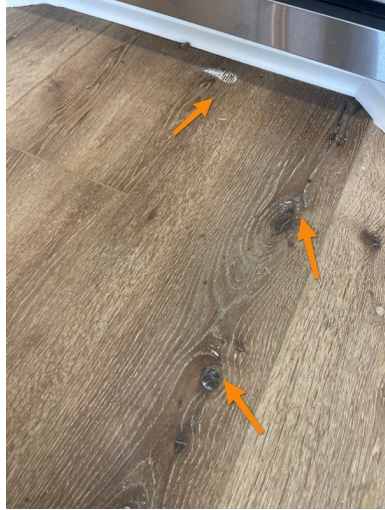
Representative Photo

3: Some type of white filler is in the floor

The what appears to be laminate or vinyl plank flooring has a white filler and all the low areas. It does not appear natural to the grain of the flooring. Recommend a qualified flooring contractor evaluate and repair if needed

Recommendation: Contact a qualified professional.

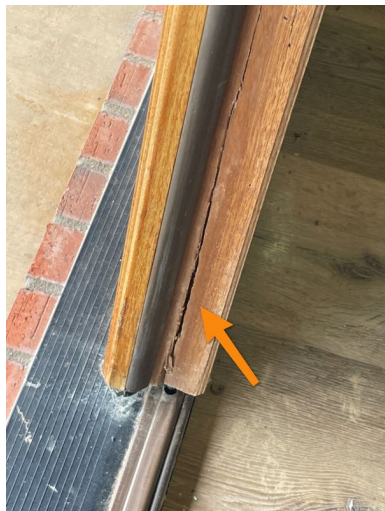
Front

One or more door were damaged. Repair as needed.

Recommendation: Contact a qualified professional.

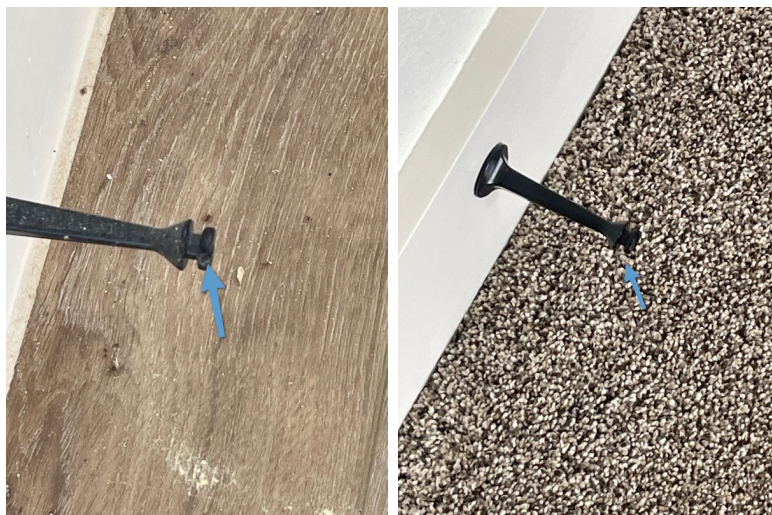
Representative Photo

2: Doorstops Missing/Damaged

One or more door stops were missing. Repair as needed.

Recommendation: Recommended DIY Project

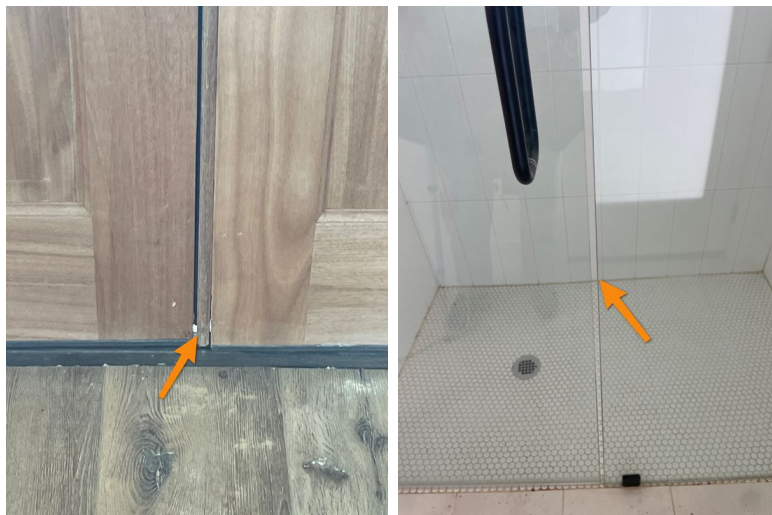
Front door

3: Noticeable Gap

One or more doors had gaps that could result in energy loss. A handyman or door contractor should evaluate and repair.

Recommendation: Contact a qualified door repair/installation contractor.

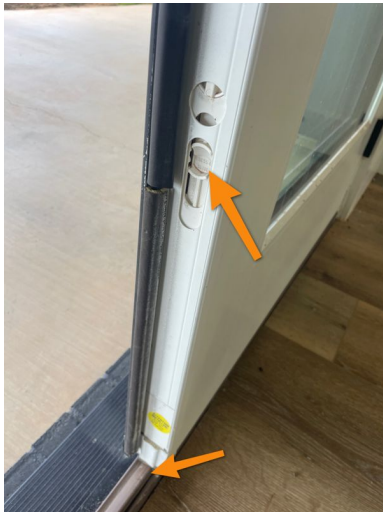
Back door

7: Door latch is damaged

This will keep door from opening. Have a qualified contractor evaluate and repair

Recommendation: Contact a qualified professional.

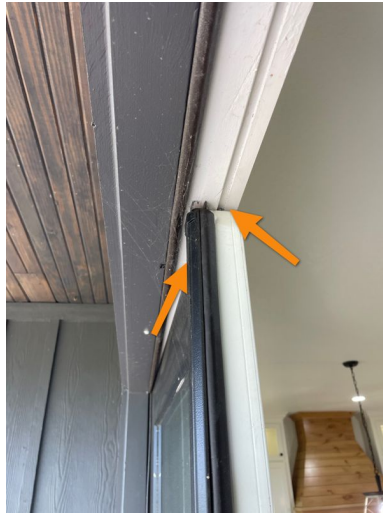
Back door

9: Evidence of moisture intrusion at door

This does not appear to be active moisture. However it is recommended to have qualified contractor evaluate why and how moisture came through the door and making any need of repairs

Recommendation: Contact a qualified professional.

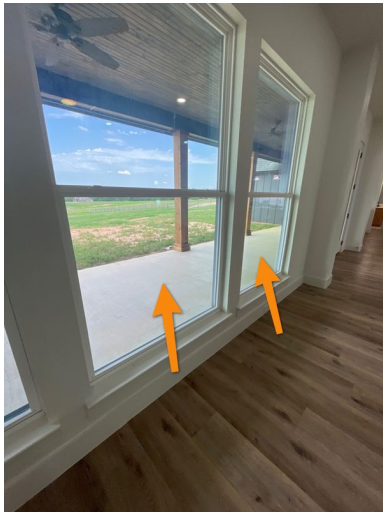
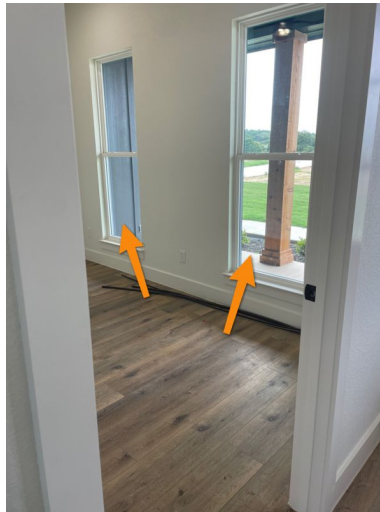
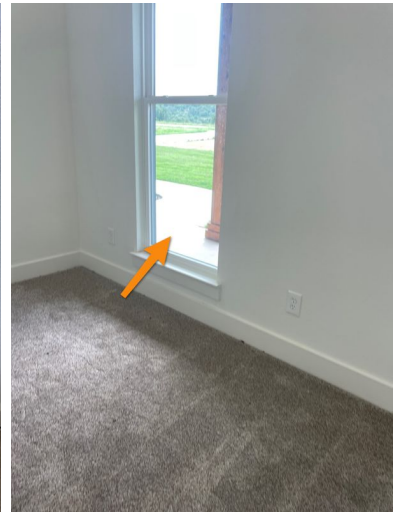
2: Screens Missing/Damaged

One or more windows had missing or damaged screens. Recommend replacement.

Recommendation: Contact a qualified window repair/installation contractor.

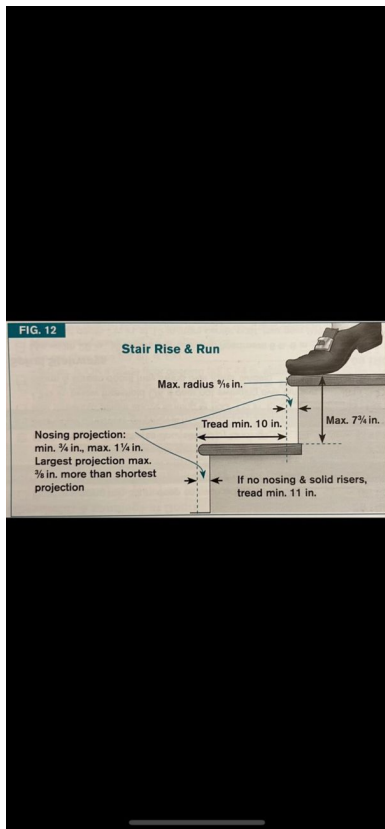
1: Stairway Tread Height/Width

The stairway tread width and/or height was improper or irregular posing a safety hazard. A qualified contractor should evaluate and make any needed repairs.

Recommendation: Contact a qualified professional.

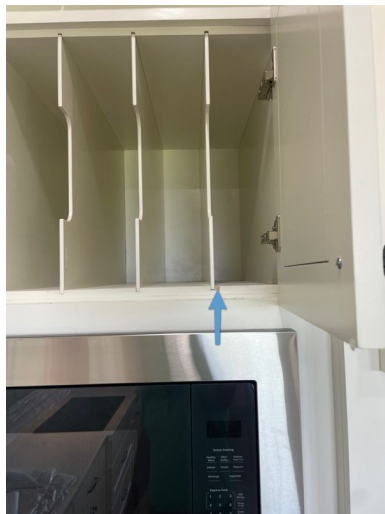
1: One or more cabinets have paint deficiencies

One amor cabinets have paint deficiencies. These are cosmetic. Paint and refinish as needed

Recommendation: Contact a qualified professional.

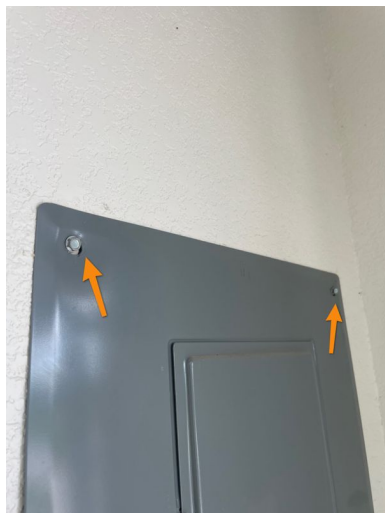
☐ Deficient

Screws with pointed ends can penetrate wires causing a shock hazard. Replace with blunt end screws

Recommendation: Contact a qualified professional.

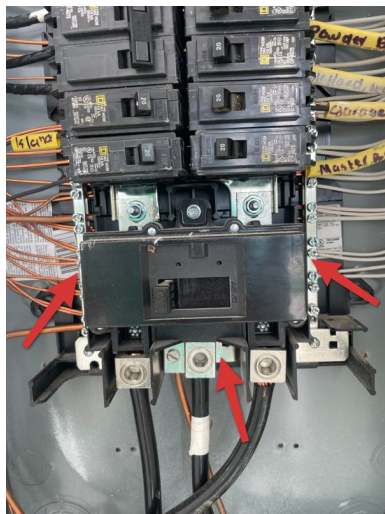
2: Sub panel has neutrals and grounds connected

Sub panel has neutrals and grounds connected. This is not proper wiring for a sub panel. This can cause shock hazards. Recommend a licensed qualified electrician evaluate and repair. Any issues with electrical panels listed and not listed.

Recommendation: Contact a qualified professional.

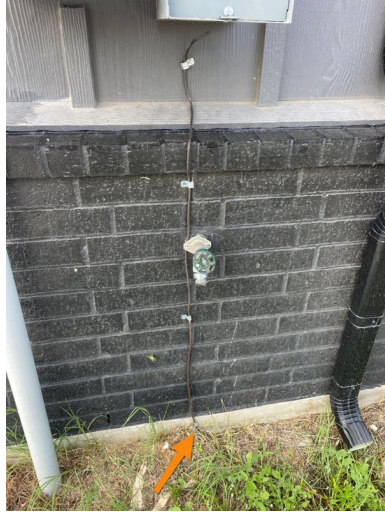
The main electrical panel is required to have two means of grounding. Example would be a grounding rod and a uffer ground. Or a grounding rod and grounding at the homes water supply line. Recommend a qualified licensed electrician evaluate and repair if needed

Recommendation: Contact a qualified professional.

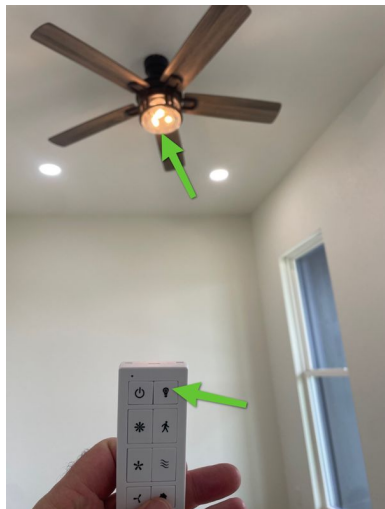
Light fixture could not be tested:

The batteries to turn the light fixture on are missing from the remote. This is for your information

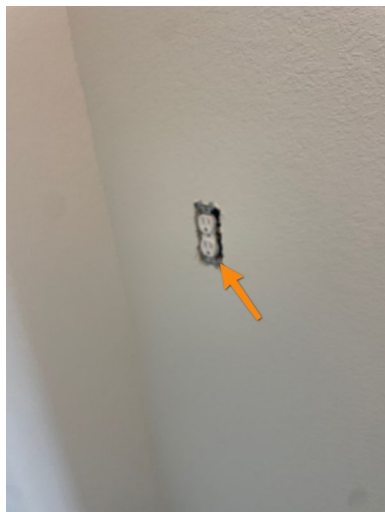
2: Cover Plates Missing/Damaged

One or more outlets or wall switches have missing or damaged cover plates. Recommend replacement.

Recommendation: Recommended DIY Project

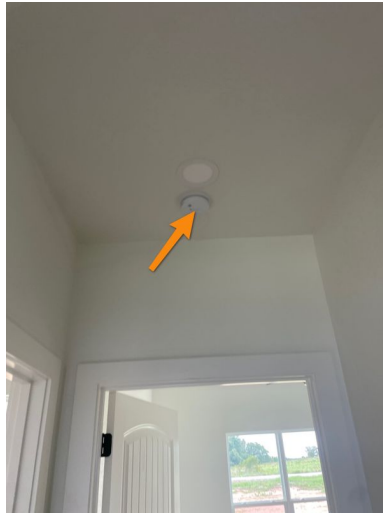
Beeps

6: Smoke Detectors Defective

One or more smoke detectors are not operating. Recommend Evaluation and repair of all smoke detectors

Recommendation: Recommended DIY Project

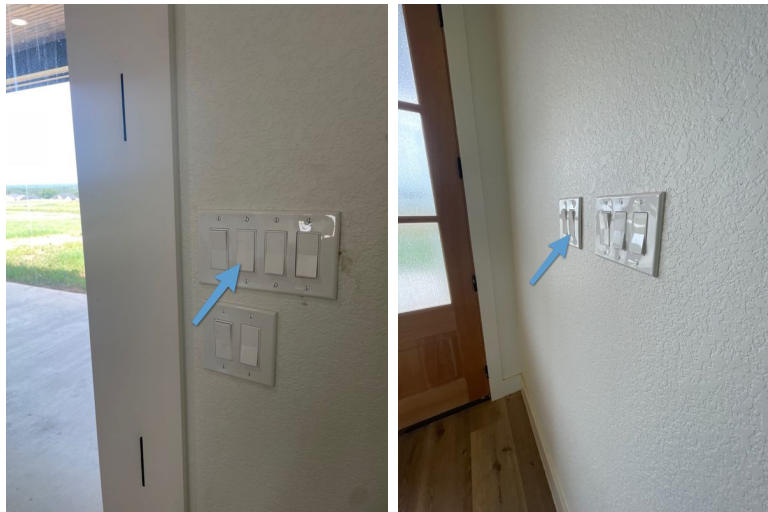
8: One or more carbon monoxide alarms missing

The absence of carbon monoxide alarms outside each separate sleeping area in the immediate vicinity of the sleeping rooms was observed. When the house has a attached garage or any fuel fired appliances carbon monoxide alarms are required. Have a qualified contractor install carbon monoxide alarms in required areas.

Recommendation: Contact a qualified professional.

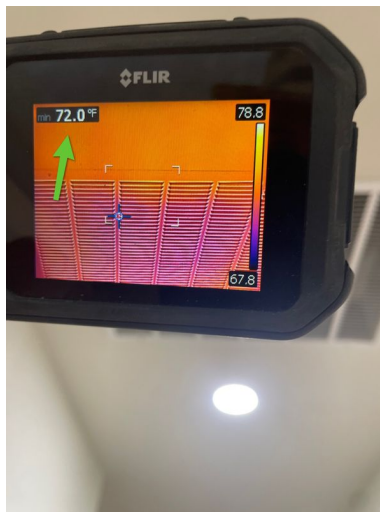
1: Primary condensate trap is not insulated

Primary condensate trap is not insulated in the attic. This can and will cause condensate to leak onto attic floor and then possibly into the house. Recommend having repaired by a qualified contractor.

Recommendation: Contact a qualified professional.

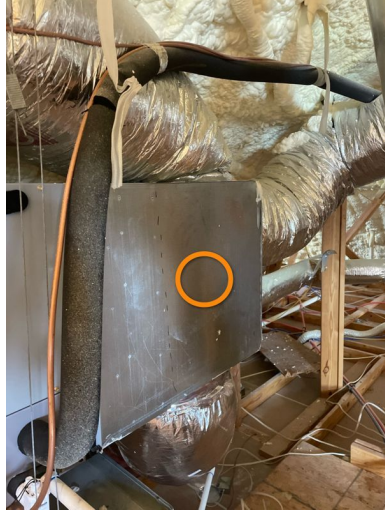
3: Air handler is missing seal around breakers

This will allow for energy loss to occur. Have a qualified contractor evaluate and repair

Recommendation: Contact a qualified professional.

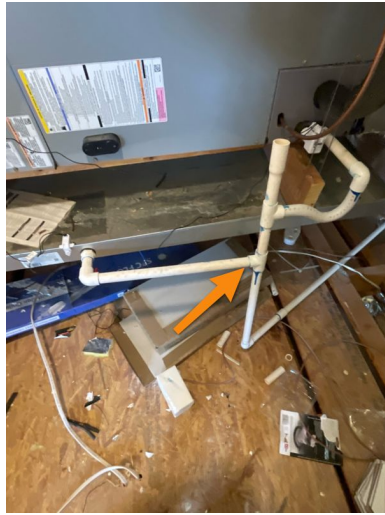
1: One or more ducts are restricted

One or more ducts are restricted. This is caused by either excessive bends or sandwiched between other components. This can restrict airflow to supply register. Repair is recommended

Recommendation: Contact a qualified professional.

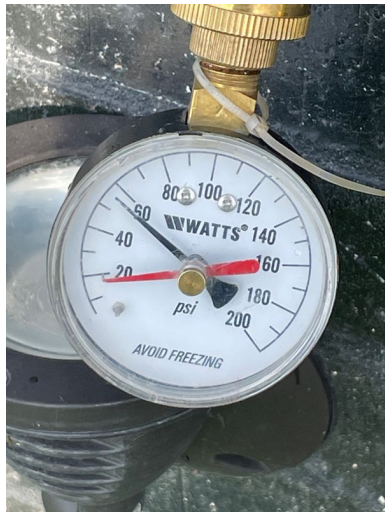
Static Water Pressure Reading: 58 psi

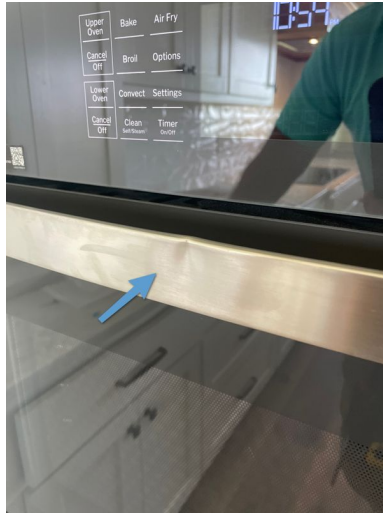
1: Oven exterior is damaged

This is cosmetic. Repair as needed

Recommendation: Contact a qualified professional.

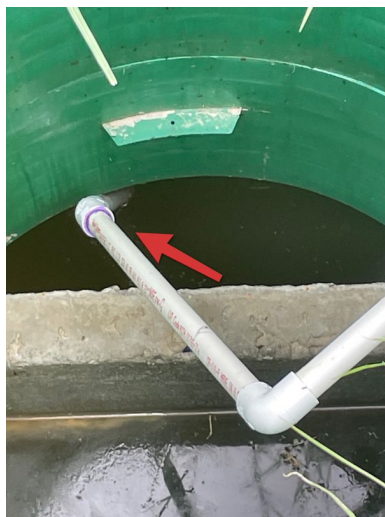
The aerator pump provides air for the bacteria that breaks down the solids. The aerator pump is not providing air into the tank. Have a qualified licensed septic contractor evaluate and repair

Recommendation: Contact a qualified professional.
