INVESTIGATOR HOME INSPECTIONS

PROPERTY INSPECTION REPORT FORM

Name of Client	07/16/2025 8:30 am Date of Inspection
, Weatherford , TX 76088	
Address of Inspected Property	
Cliff Snyder	Pro. Real Estate Inspector TREC # 23321
Name of Inspector	TREC License #
Name of Sponsor (if applicable)	TREC License #

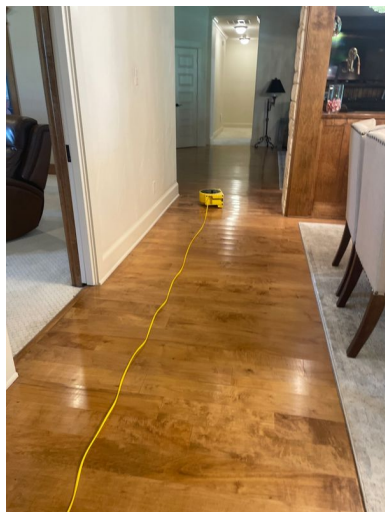
The foundation was measured using a digital level device which provides elevation information about the homes foundation. Base unit locations are identified with 0.0* measurement. Measurement points are relative to the base unit and are in tenths (0.1) of an inch.

A diagram with measurements is provided.

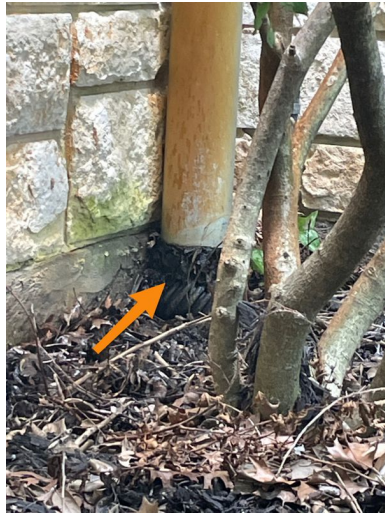
One or more downspouts have become disconnected. Repair as needed.

Recommendation: Recommended DIY Project

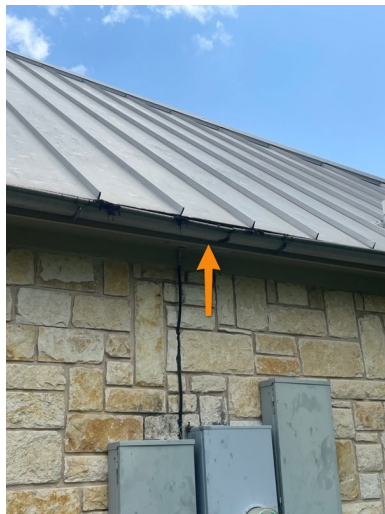
The gutter was damaged in areas. Repair as needed.

Recommendation: Contact a qualified gutter contractor

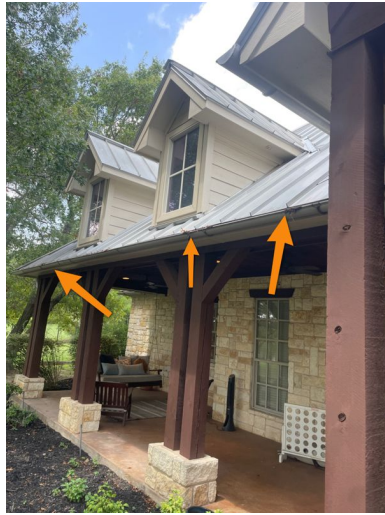
The gutters have some debris in areas and should to be cleaned. The debris in gutters can also conceal rust, deterioration, or leaks that are not visible until cleaned.

Recommendation: Recommended DIY Project

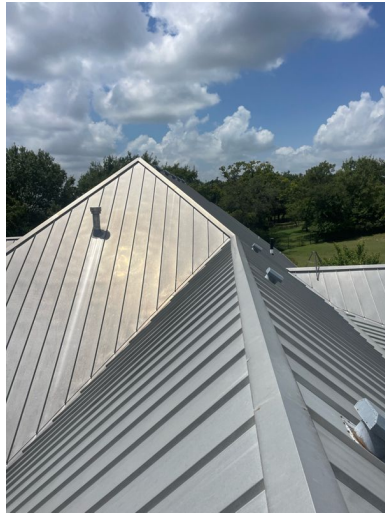
1: Coverings Damaged

Roof coverings exhibited general damage that could affect performance. Recommend a qualified roofer evaluate and repair any issues with roof listed and not listed on the report.

Recommendation: Contact a qualified roofing professional.

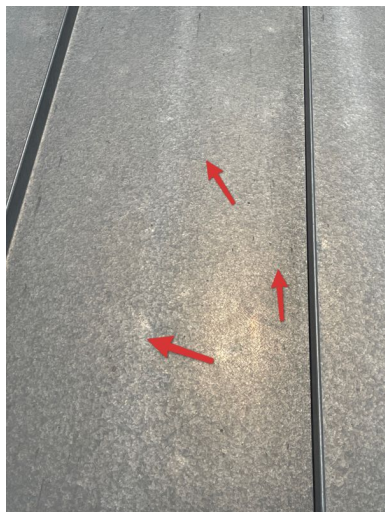
Hail damage all over

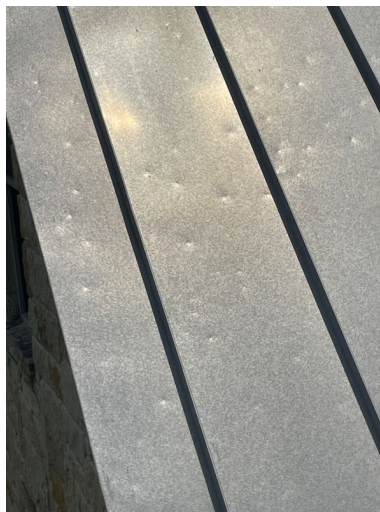
Hail damage

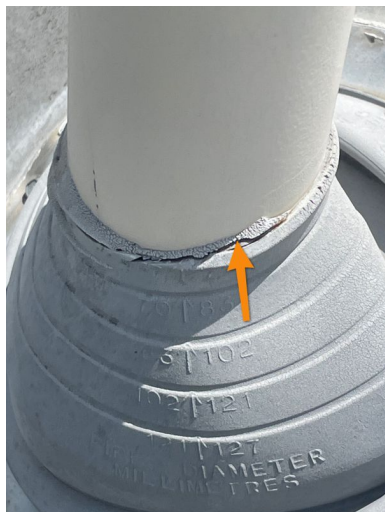
Flashing was loose, missing, or damaged. A roofing contractor should evaluate the flashing details and make any needed repairs.

Recommendation: Contact a qualified roofing professional.

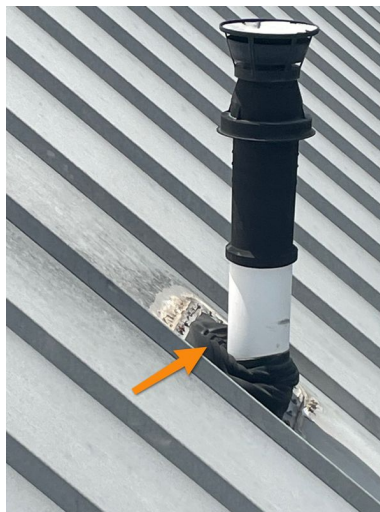
2: Flashing Loose/Missing/Damaged

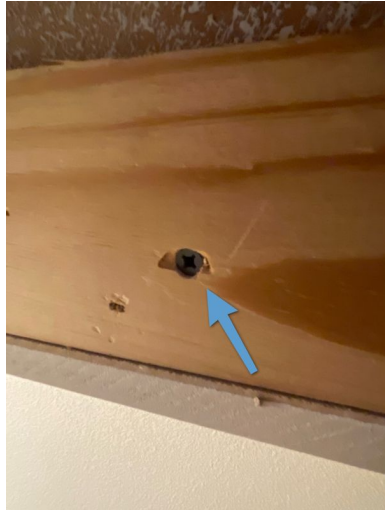
Attic stairs not secured with proper fasteners. This can cause stairs to become loose overtime. Have a qualified contractor evaluate and repair.

Recommendation: Contact a qualified professional.

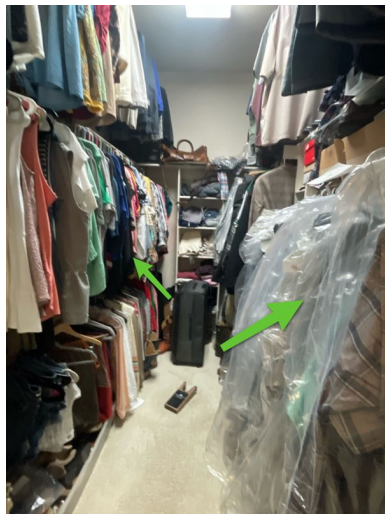
Some walls were covered with personal property. This made the inspection of the concealed walls incomplete. This is for your information.

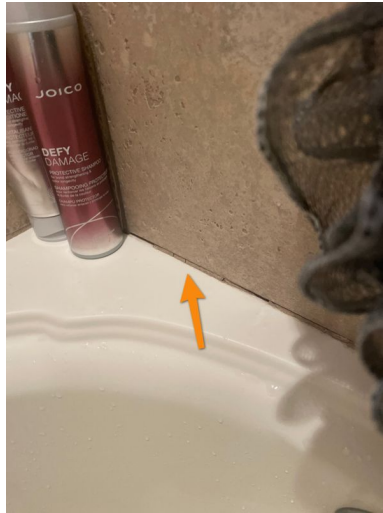
Five Bathroom

1: Bath Grout/Caulk

Grout and/or caulk improvements are needed at one or more wet locations. Repair as needed.

Recommendation: Contact a qualified professional.

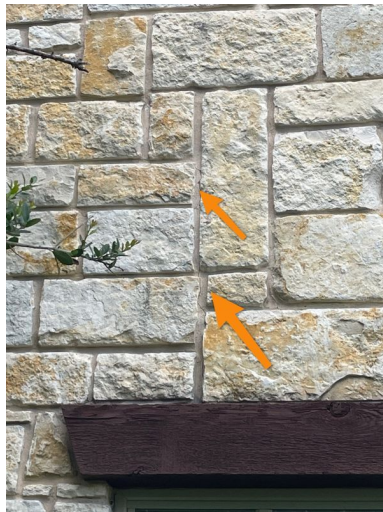
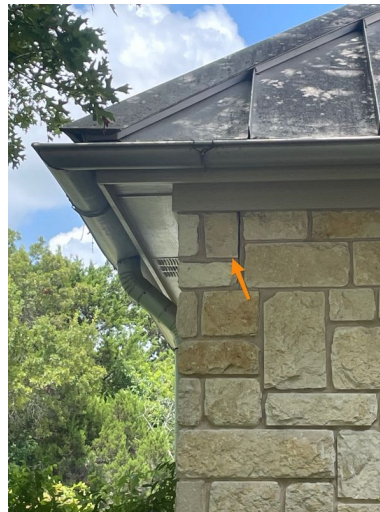
2: Brick/Mortar Separation Minor

Minor brick or mortar separations were noted. Water can entered behind masonry cladding and cause additional damage. Recommend repair as needed to prevent further deterioration.

Recommendation: Recommended DIY Project

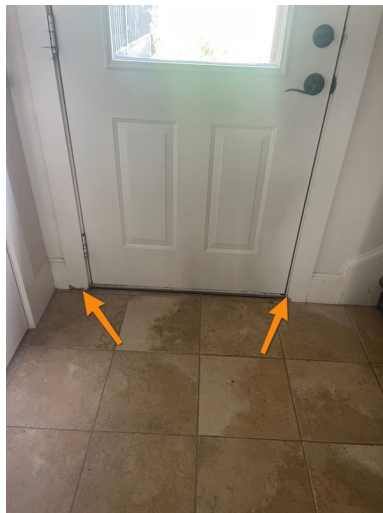
4: Moisture Intrusion Inactive

One or more areas had signs of moisture intrusion. A moisture meter was used which did not record elevated moisture levels. Additional information should be obtained from the current owner about history and known issues.

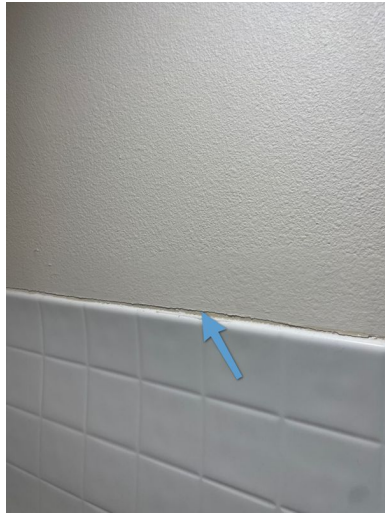
2nd Floor Bathroom

5: Interior Paint/Stain Failing Minor

Minor areas of failing paint or stain were noted around the interior. Recommend prep, prime, and paint as necessary.

Recommendation: Contact a qualified painting contractor.

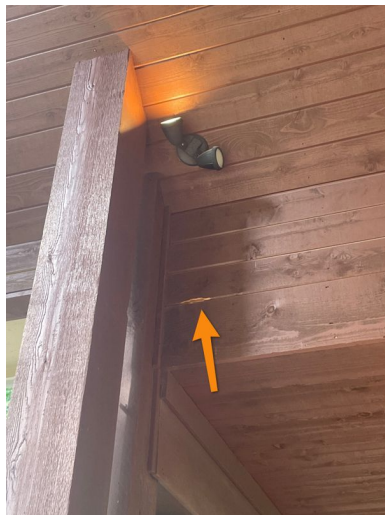
One or more areas of the exterior cladding (brick, stone, siding, trim) was damaged or deteriorated. Further deterioration can occur if not corrected. Recommend repair by a qualified contractor.

Recommendation: Contact a qualified professional.

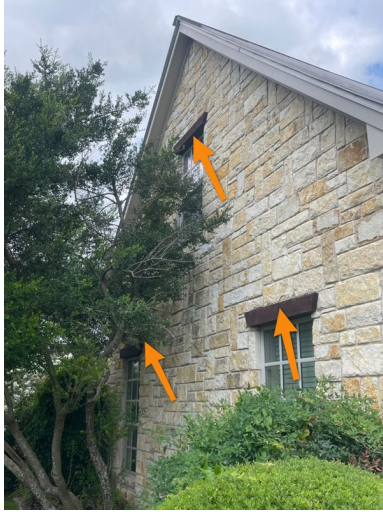
7: Improper flashing at one or more areas on exterior siding

Improper flashing at one or more areas on exterior siding. This can allow water to enter behind the siding. Recommend a qualified siding installer evaluate and make any need the repairs to the exterior siding

Recommendation: Contact a qualified professional.

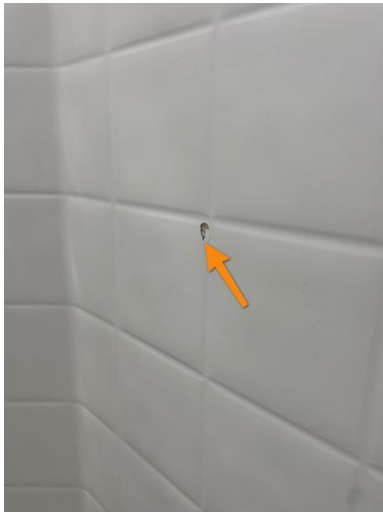
2nd Floor

8: Shower enclosure has a hole present

This appears to be cosmetic. Recommend monitoring and repair as needed

Recommendation: Contact a qualified professional.

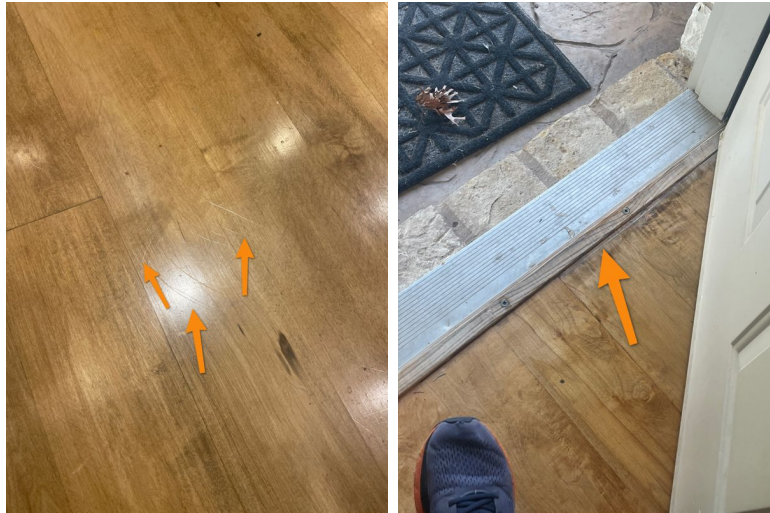
The flooring had general damage visible at the time of the inspection. Recommend repair as needed.

Scuffs Representative Photo

Recommendation: Contact a qualified flooring contractor

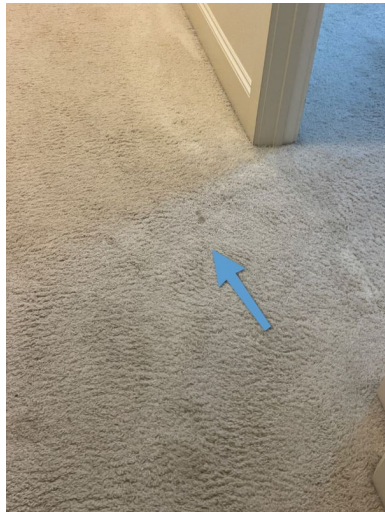
The flooring is heavily soiled. Clean or replace as needed.

Recommendation: Contact a qualified professional.

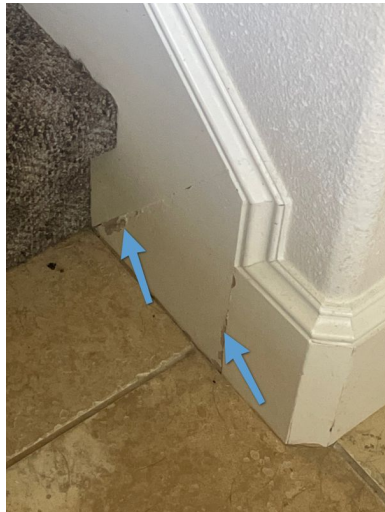
One or more areas of baseboards have paint deterioration. Recommend repaint as needed.

Recommendation: Contact a qualified professional.

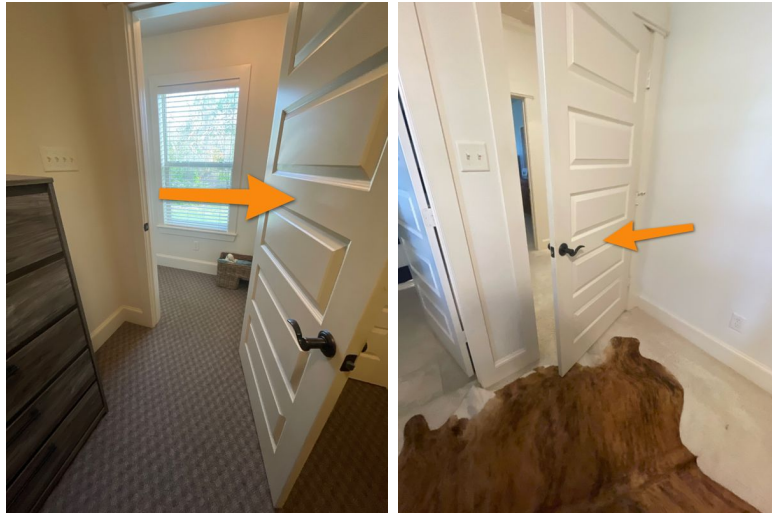
One or more doors self close or open. Repair as needed.

Recommendation: Contact a qualified professional.

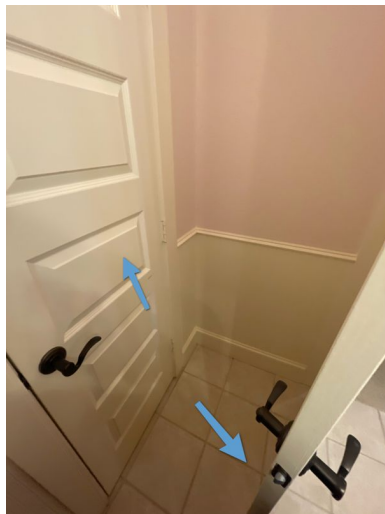
One or more door stops were missing. Repair as needed.

Recommendation: Recommended DIY Project

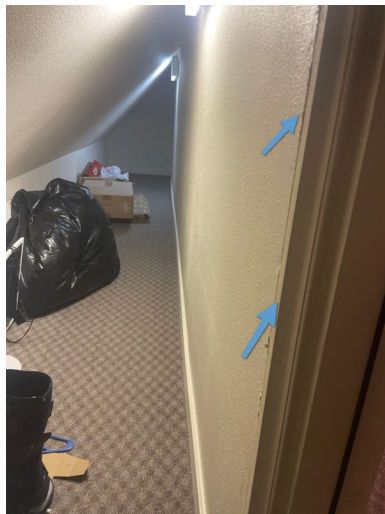
2nd Floor Closet

Door trim was missing or damaged. Repair as needed.

Recommendation: Contact a handyman or DIY project

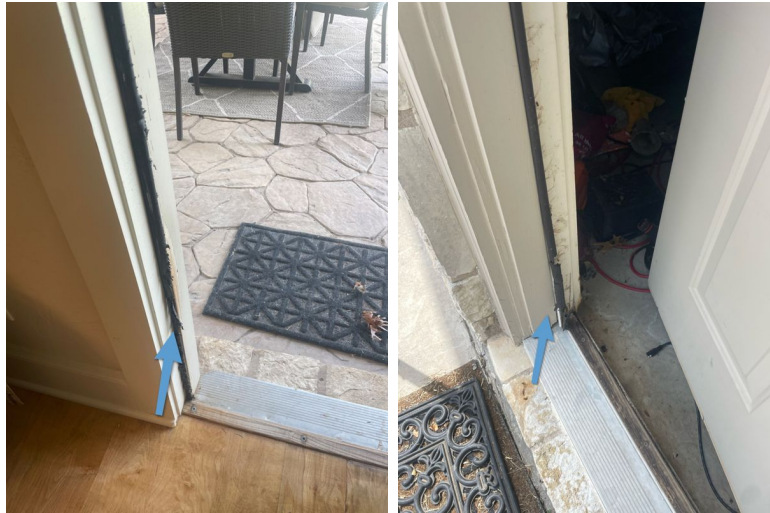
One or more doors have missing or damaged weather stripping or door sweeps. Energy loss can occur if not corrected. Recommend repair as needed.

Recommendation: Recommended DIY Project

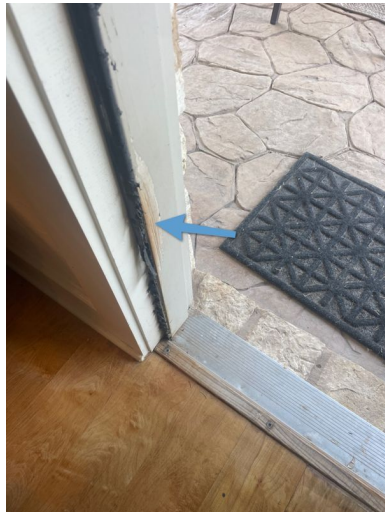
One or more areas of door trim have paint deterioration. Repair as needed

Recommendation: Contact a qualified professional.

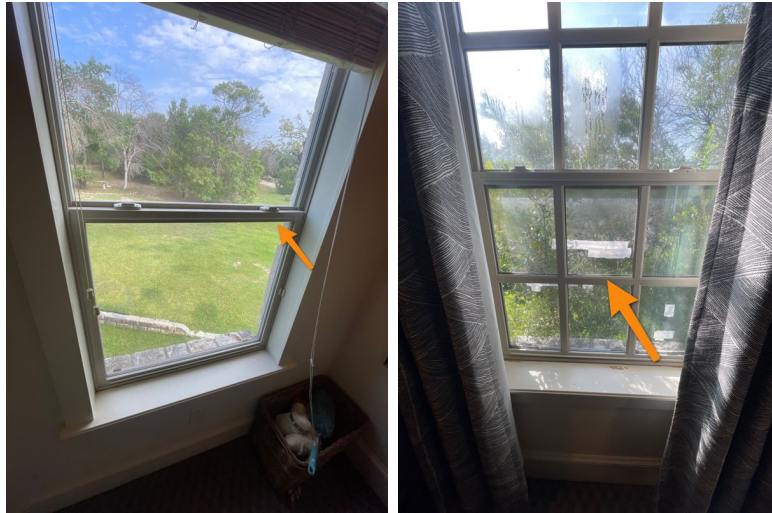
2nd Floor Bedroom

One or more windows were difficult to open or close. A qualified contractor should evaluate and make any needed repairs.

Recommendation: Contact a qualified window repair/installation contractor.

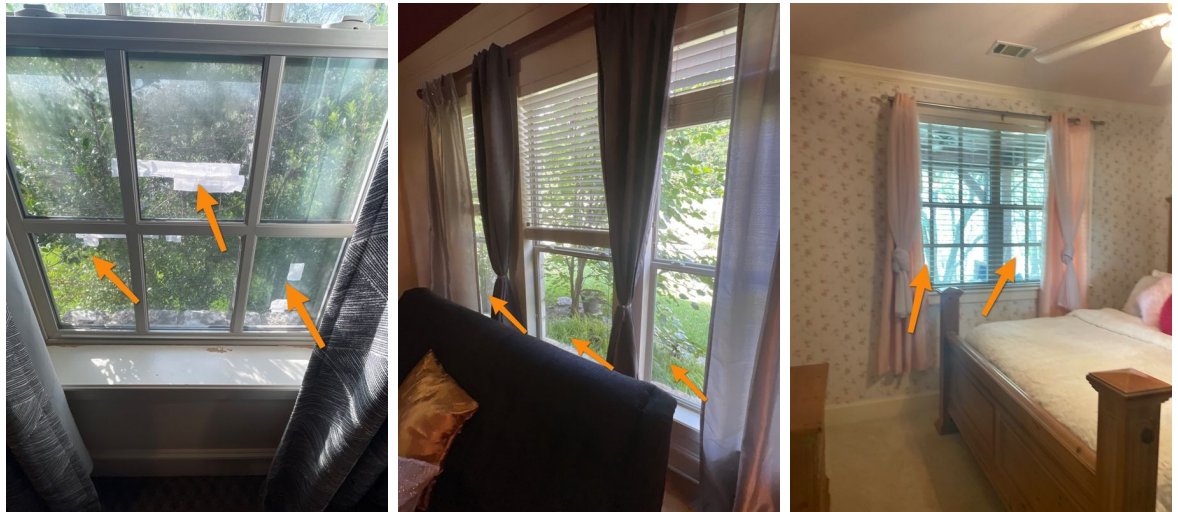
2nd Floor Bedroom

One or more windows had missing or damaged screens. Recommend replacement.

Recommendation: Contact a qualified window repair/installation contractor.

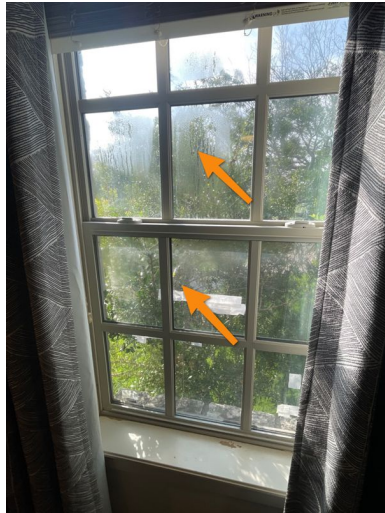
Representative Photo 2nd Floor
Bedroom

One or more windows were cloudy or display other evidence of broken seals. Seals between window panes offer some insulation benefits. A qualified contractor should evaluate all windows in these locations and repair as needed.

Recommendation: Contact a qualified window repair/installation contractor.

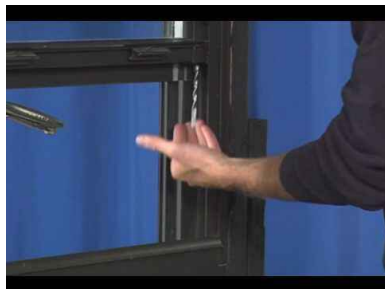
Spiral Balance

One or more windows had damaged spiral or missing spring balances (which help keep the window open). A qualified contractor should repair as needed.

Recommendation: Contact a qualified window repair/installation contractor.

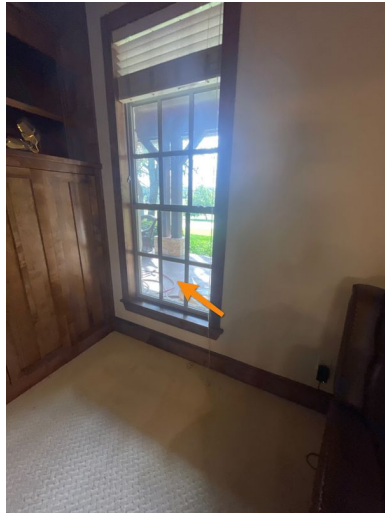
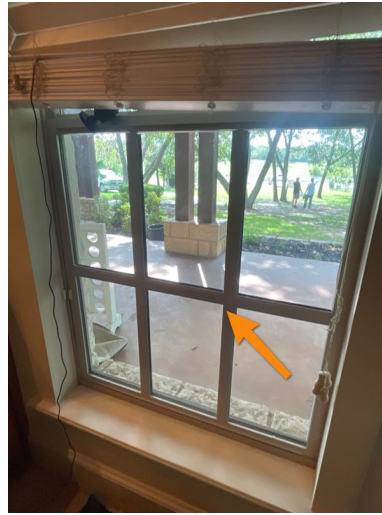
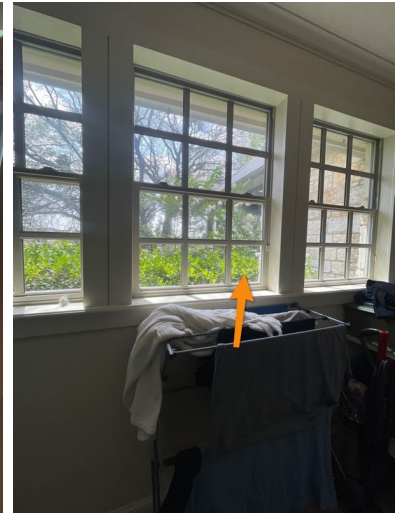
Left Side(Facing Front) Bathroom

One or more windows are stuck shut. Recommend windows be restored to functional use.

Recommendation: Contact a qualified window repair/installation contractor.

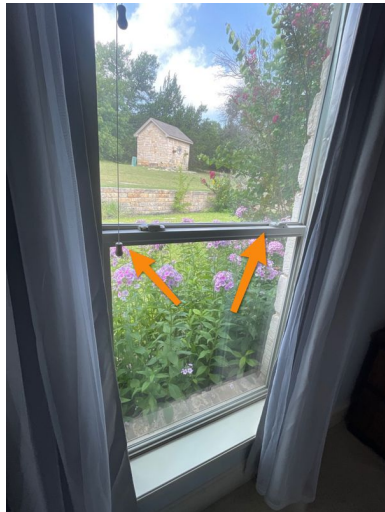
One or more windows did not lock properly. A qualified person should repair as needed.

Recommendation: Contact a qualified professional.

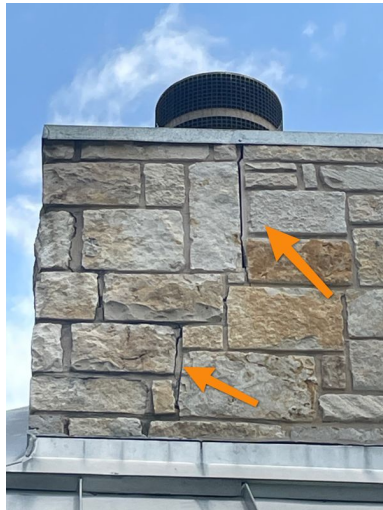
The chimney siding is damaged or deteriorated. Further deterioration or water intrusion can occur if not corrected. Recommend repair by a qualified contractor.

Recommendation: Contact a qualified siding specialist.

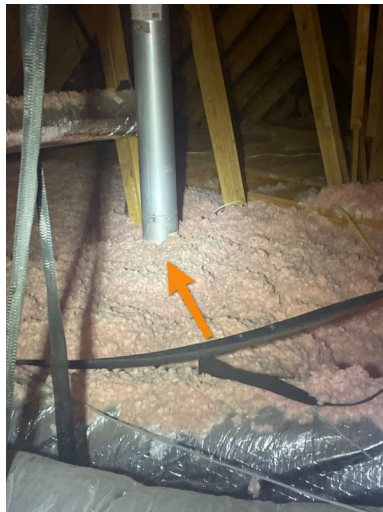
3: Chimney flue in contact with attic insulation

Chimney flue in contact with attic insulation. There should be a space in between the chimney flue and any combustibles including attic insulation. Have a qualified contractor repair.

Recommendation: Contact a qualified professional.

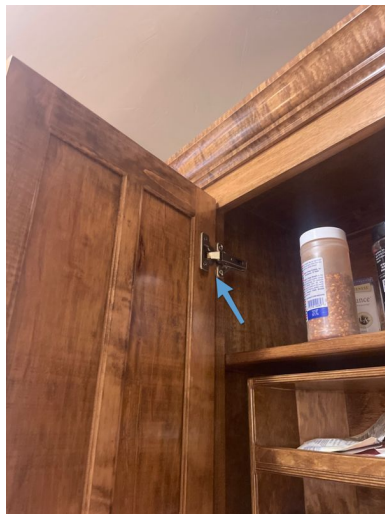
Cabinet hardware loose. This can cause doors to be slightly out of alignment or not close properly. This is a minor repair.

Recommendation: Contact a qualified professional.

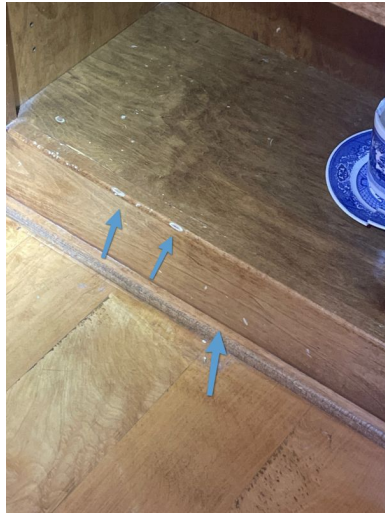
Representative Photo

One amor cabinets have paint deficiencies. These are cosmetic. Paint and refinish as needed

Recommendation: Contact a qualified professional.

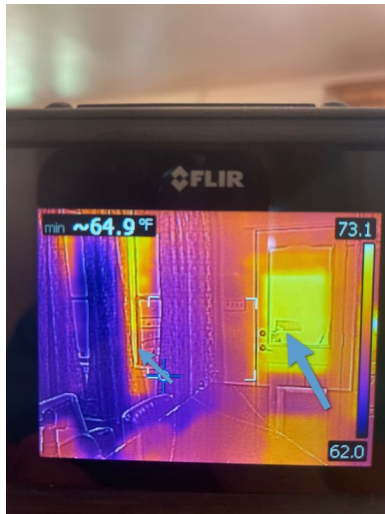
Representative Photo

The thermal imaging camera shows typical signs of any energy transfer doors and windows. This is for your information

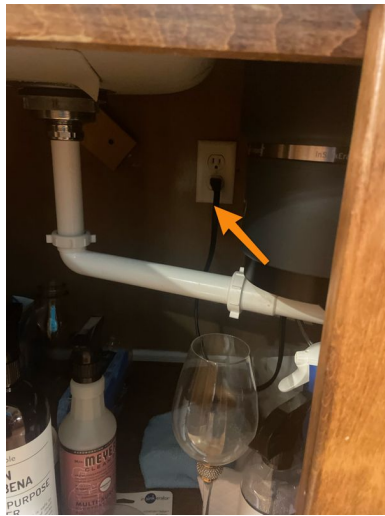
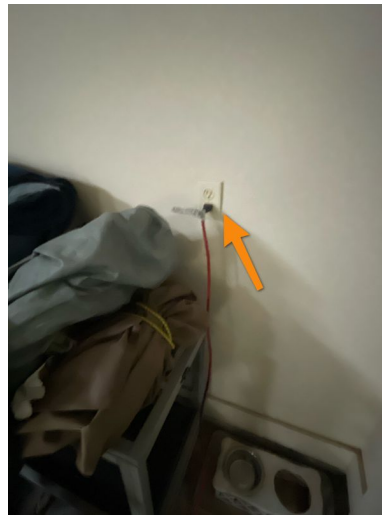
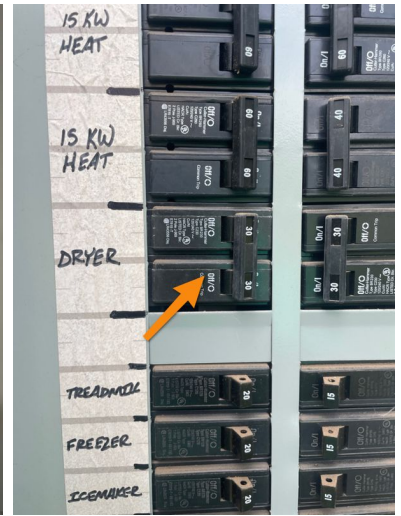
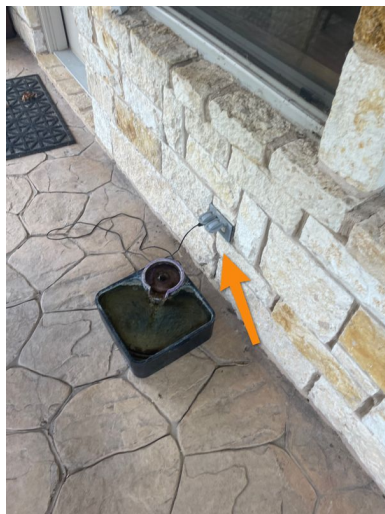
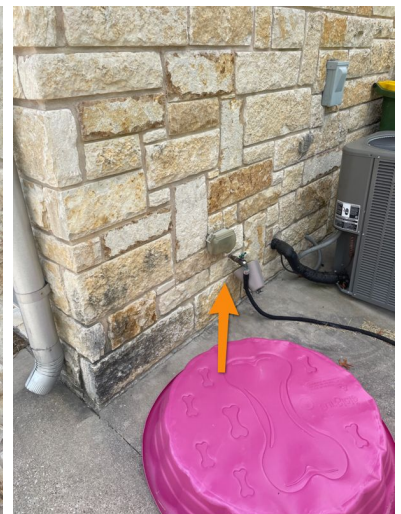
GFCI (Ground Fault Circuit Interrupter) protection should be present at all bathroom receptacles, garage receptacles, outdoor receptacles, crawl space receptacles, unfinished basement receptacles, kitchen countertop receptacles, laundry room receptacles, kitchen dishwasher, kitchen dishwasher receptacle and receptacles that are located within six feet of the outside edge of a sink, shower or tub. GFCI outlets are missing at one or more locations. The inspector recommends repair by a licensed electrician.

Recommendation: Contact a qualified electrical contractor.

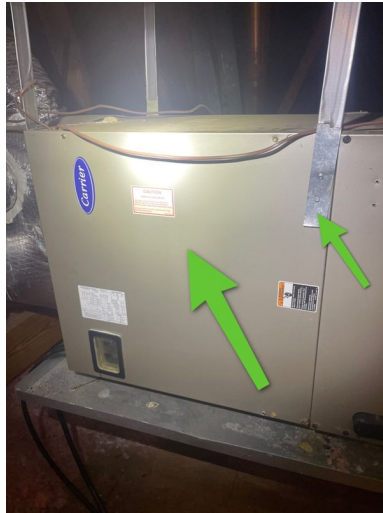
Middle right unit

1: Previous signs of condensation in secondary pan

Previous signs of condensation in secondary pan. Recommend monitoring for additional condensation in secondary pan.

Recommendation: Contact a qualified professional.

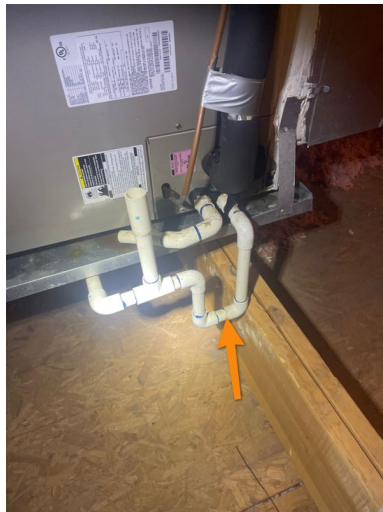
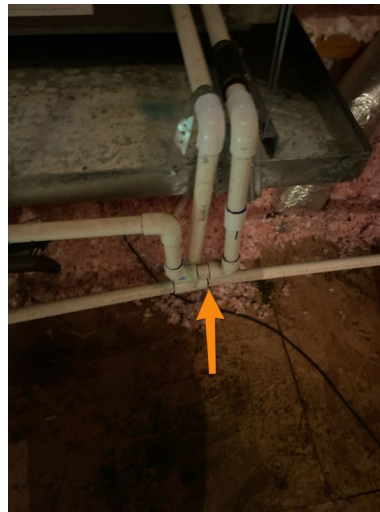
4: Condensation in secondary pan

Condensation in secondary pan. This is a sign that condensation is leaking out of either the secondary condensate drain or leaking out of the air handler. Recommend having a licensed HVAC contractor evaluate and make any need repairs

Recommendation: Contact a qualified professional.

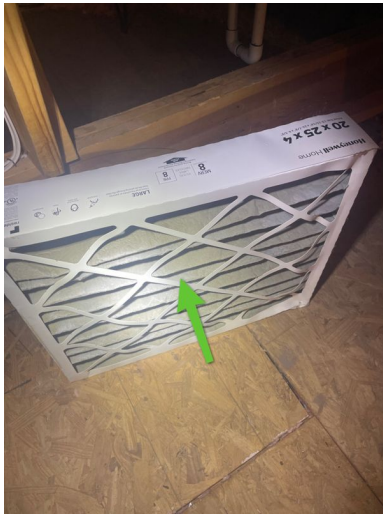
One or more filters are dirty and should be replaced. Replace as needed.

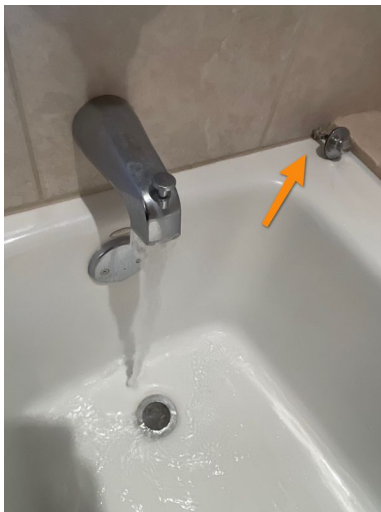
2: Faucet Leaks

One or more faucets leaked when operated. Have a qualified plumbing contractor evaluate and repair

Recommendation: Contact a handyman or DIY project

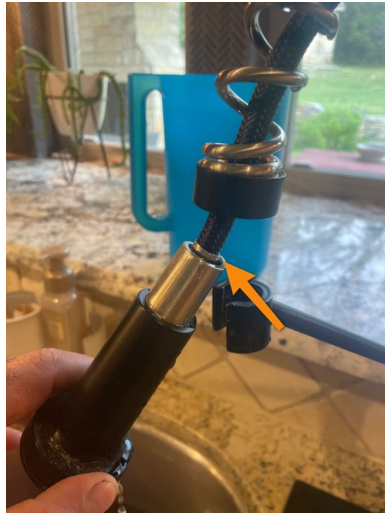
3: Flow Weak

One or more fixtures were weak in volume and/or pressure compared to other fixtures in the home. Recommend further evaluation and repair by a licensed plumber. Recommend having water well fully inspected to insure low pressure issues not caused by the well or well equipment.

Recommendation: Contact a qualified plumbing contractor.

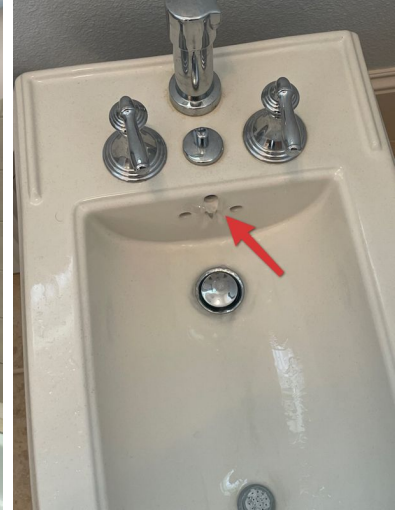
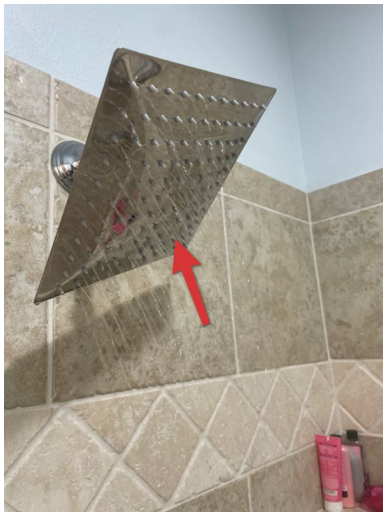
4: Tub Faucet Diverter Leaks

One or more tub faucets leaks a stream through the tub spout when the shower is on. Repair as needed.

Recommendation: Recommended DIY Project

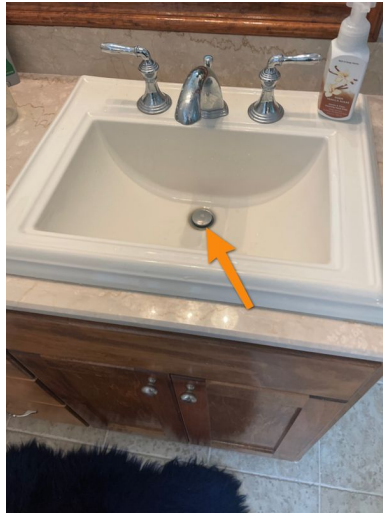
Slow

One or more drains or waste lines were clogged or slow. Recommend repair by a licensed plumber.

Recommendation: Contact a qualified plumbing contractor.

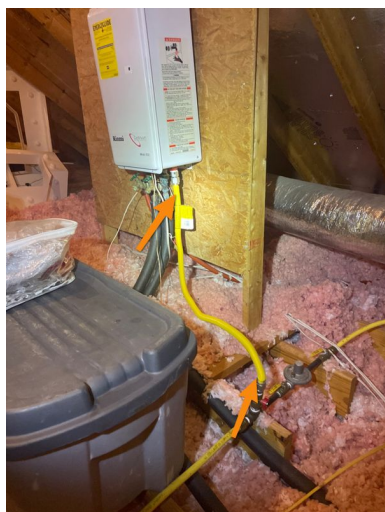
No drip legs on major gas fired appliances such as water heater and furnace. Certain municipalities or code at time of install may not have required drip legs current standards have drip legs as a requirement. Drip legs help catch moisture in small particles from gas supply. Have a qualified plumbing contractor evaluate and repair if needed.

Recommendation: Contact a qualified professional.

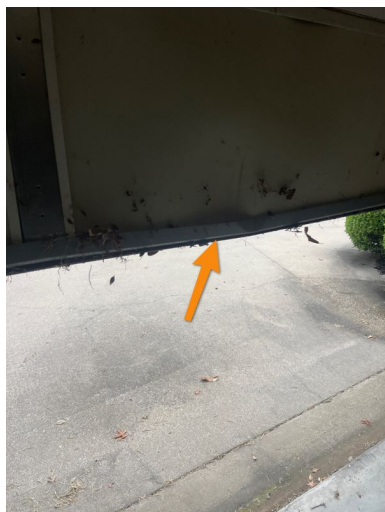
1: Damage (Minor)

The garage door had minor damage in one or more areas, but is not significantly affecting the garage door operation. Repair is recommended as needed.

Recommendation: Contact a qualified garage door contractor.

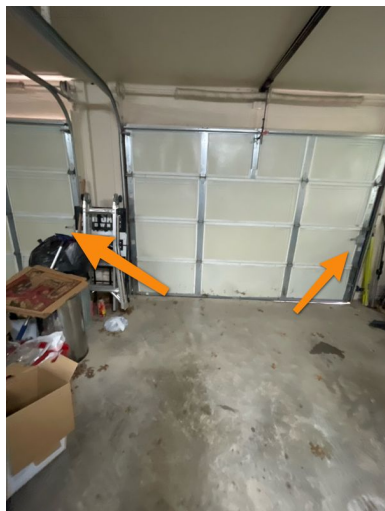
Garage door locks should be removed or disabled when automatic openers are installed. Accidental damage to the garage door can occur when the locks are engaged and the automatic opener activates, This is a small repair. Repair is recommended.

Recommendation: Recommended DIY Project

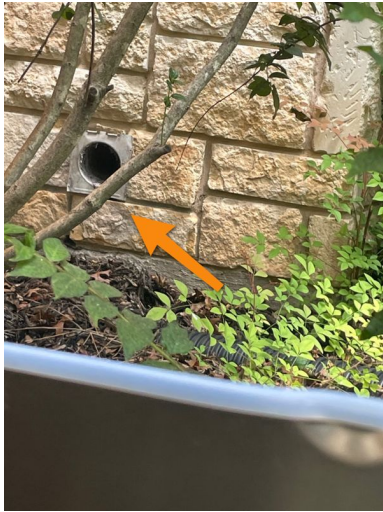
1: Vent Hood Missing/Damaged

The dryer exhaust vent had a missing or damaged vent hood outside. Repair is recommended.

Recommendation: Recommended DIY Project

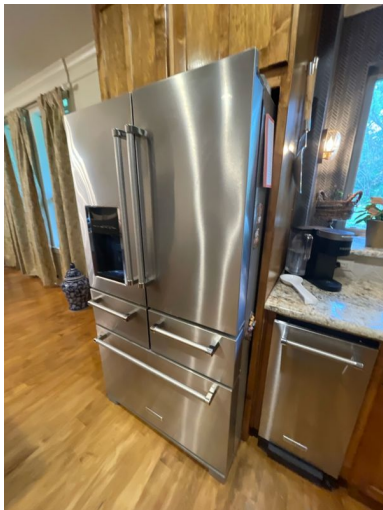
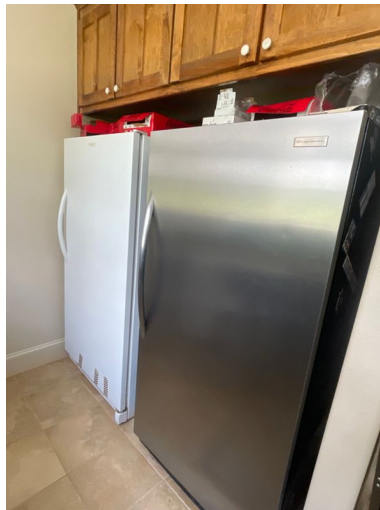
The refrigerator was not moved. Therefore if there are unknown deficiencies present they were unable to be evaluated or inspected. This is for your information.

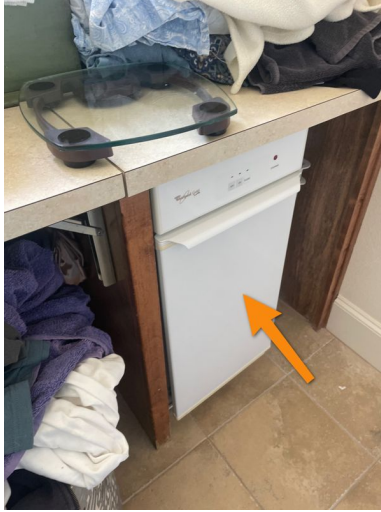
1: Icemaker not operational

I recommend having a qualified appliance contractor evaluate and repair as needed

Recommendation: Contact a qualified professional.

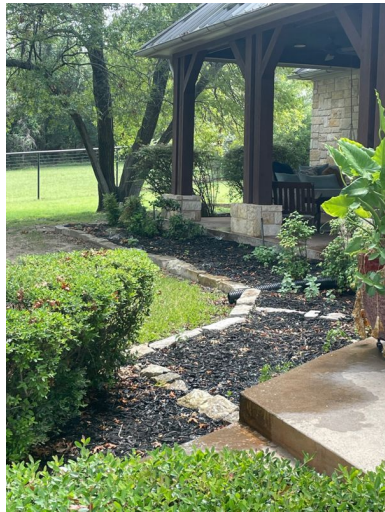
One or more sprinkler heads or drip irrigation lines did not operate properly. Repair is recommended.

Recommendation: Contact a handyman or DIY project
